BRE Global Classification Report

**Classification of fire performance in accordance with BR 135: 2013
Annex A for d+b facades rain screen cladding system.**

Prepared for: d+b facades (UK) Ltd.

Report Number: P109241-1001 Issue 1

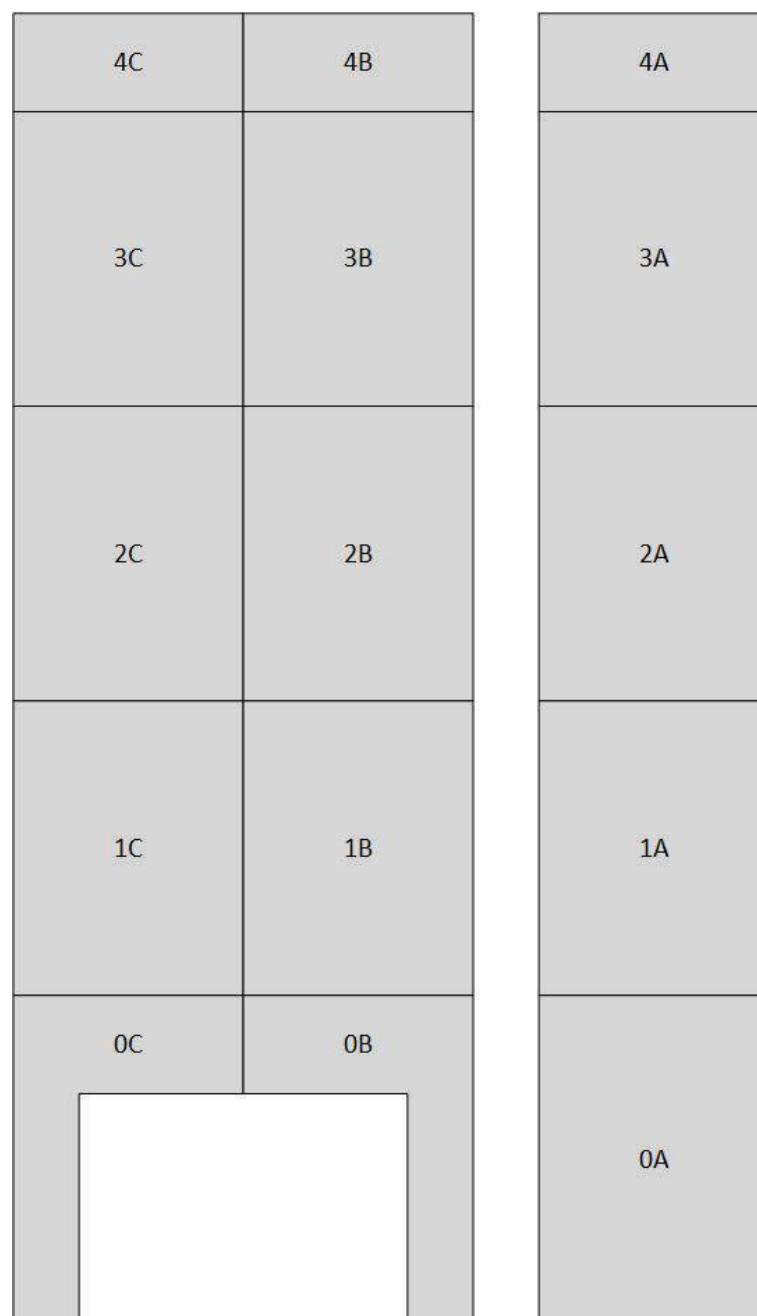
Figure 1. Layout of panels and numbering system used for reporting in Section 4.3. Not to scale.

- Panel 0A showed significant distortion with 50% dark discolouration and 50% white discolouration tapering from the top of the panel across approximately 75% of the height.
- Panel 0B was 90% consumed. The remaining panel was discoloured.
- Panel 0C was 30% consumed. Approximately 25% of the panel was discoloured white, the remaining 55% was undamaged.

- Panel 1A was discoloured white across 90% of the surface area and dark discolouration on the rest of the panel. Slight distortion.
- Panel 1B was 90% consumed and discoloured white on the remaining panel.

- Panel 1C was 20% consumed and distorted such that the right-hand edge of the panel tended away from the insulation.
- Panel 2A remained intact but was distorted and discoloured.

- Panel 2B was <10% consumed at the base and with approximately 85% discoloured white and the top right-hand corner discoloured black.
- Panel 2C was <5% consumed at the base (along the centre line of the combustion chamber) with 60% discoloured white where exposed to direct flame impingement and discoloured black at the outside edge.

- Panel 3A was intact with minimal signs of damage.
- Panels 3B&3C was 5% discoloured black at the base (along the centre line of the combustion chamber)

- Panels 4A-4C were intact with no visible signs of damage.
