BRE Global Test Report

BS 8414-1:2015 + A1:2017 test on d+b facades rain screen cladding system with 100mm-thick Rockwool insulation and aluminium cassette panels.

Prepared for:d+b facades (UK) Ltd.Date:1st December 2017Report Number:P109241-1000 Issue: 1

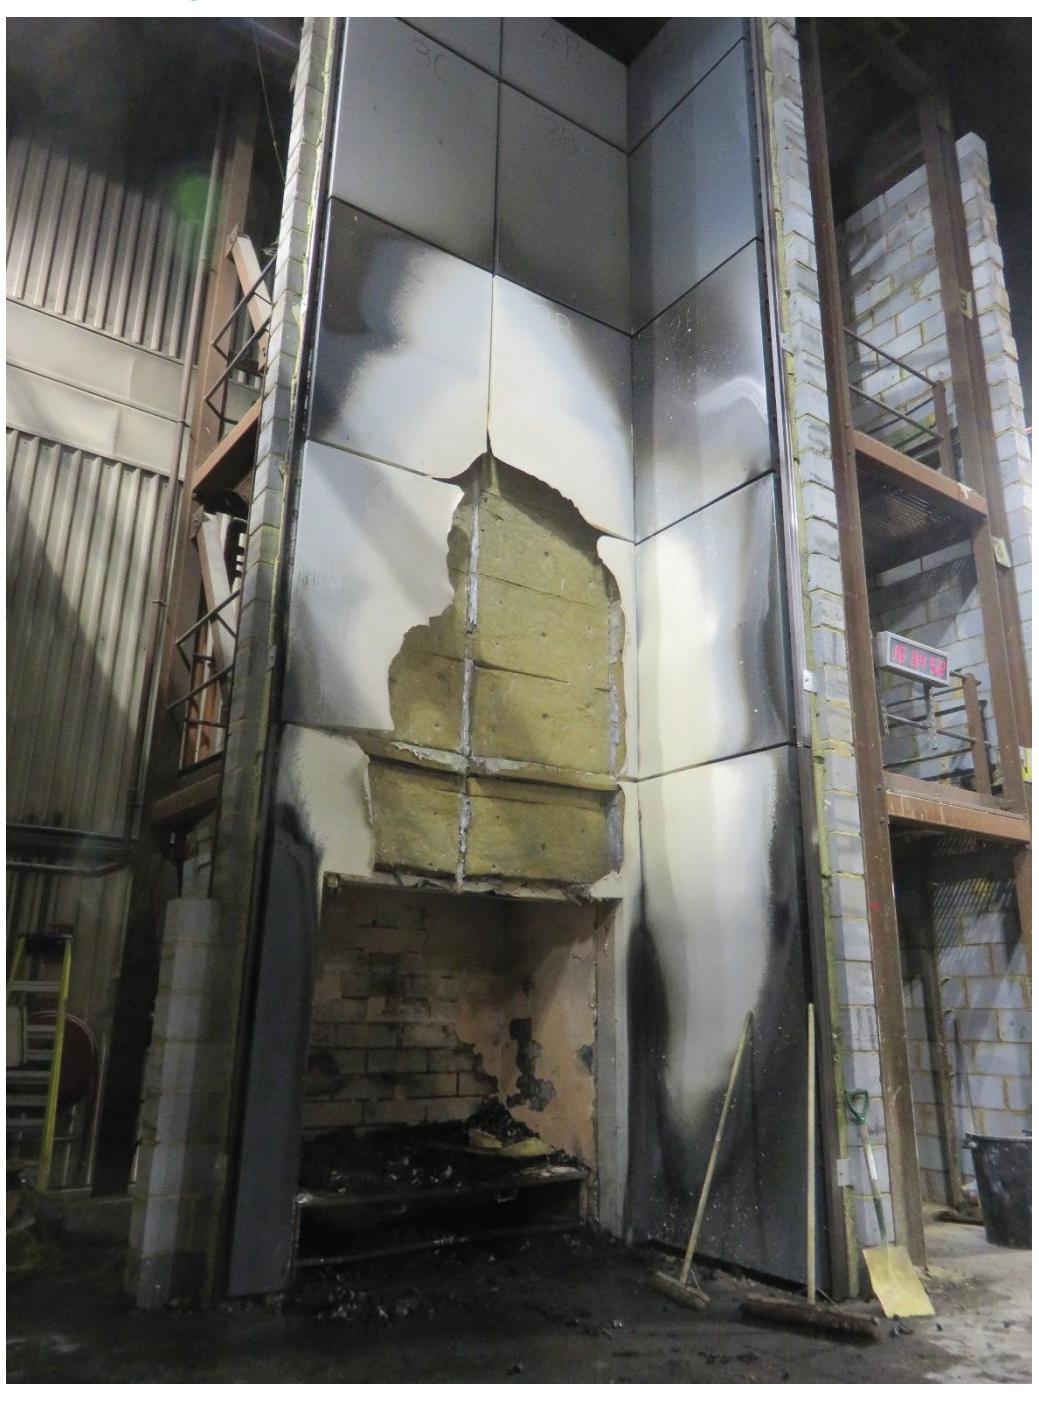
Figure 19. Full height photograph of the cladding system post-test.

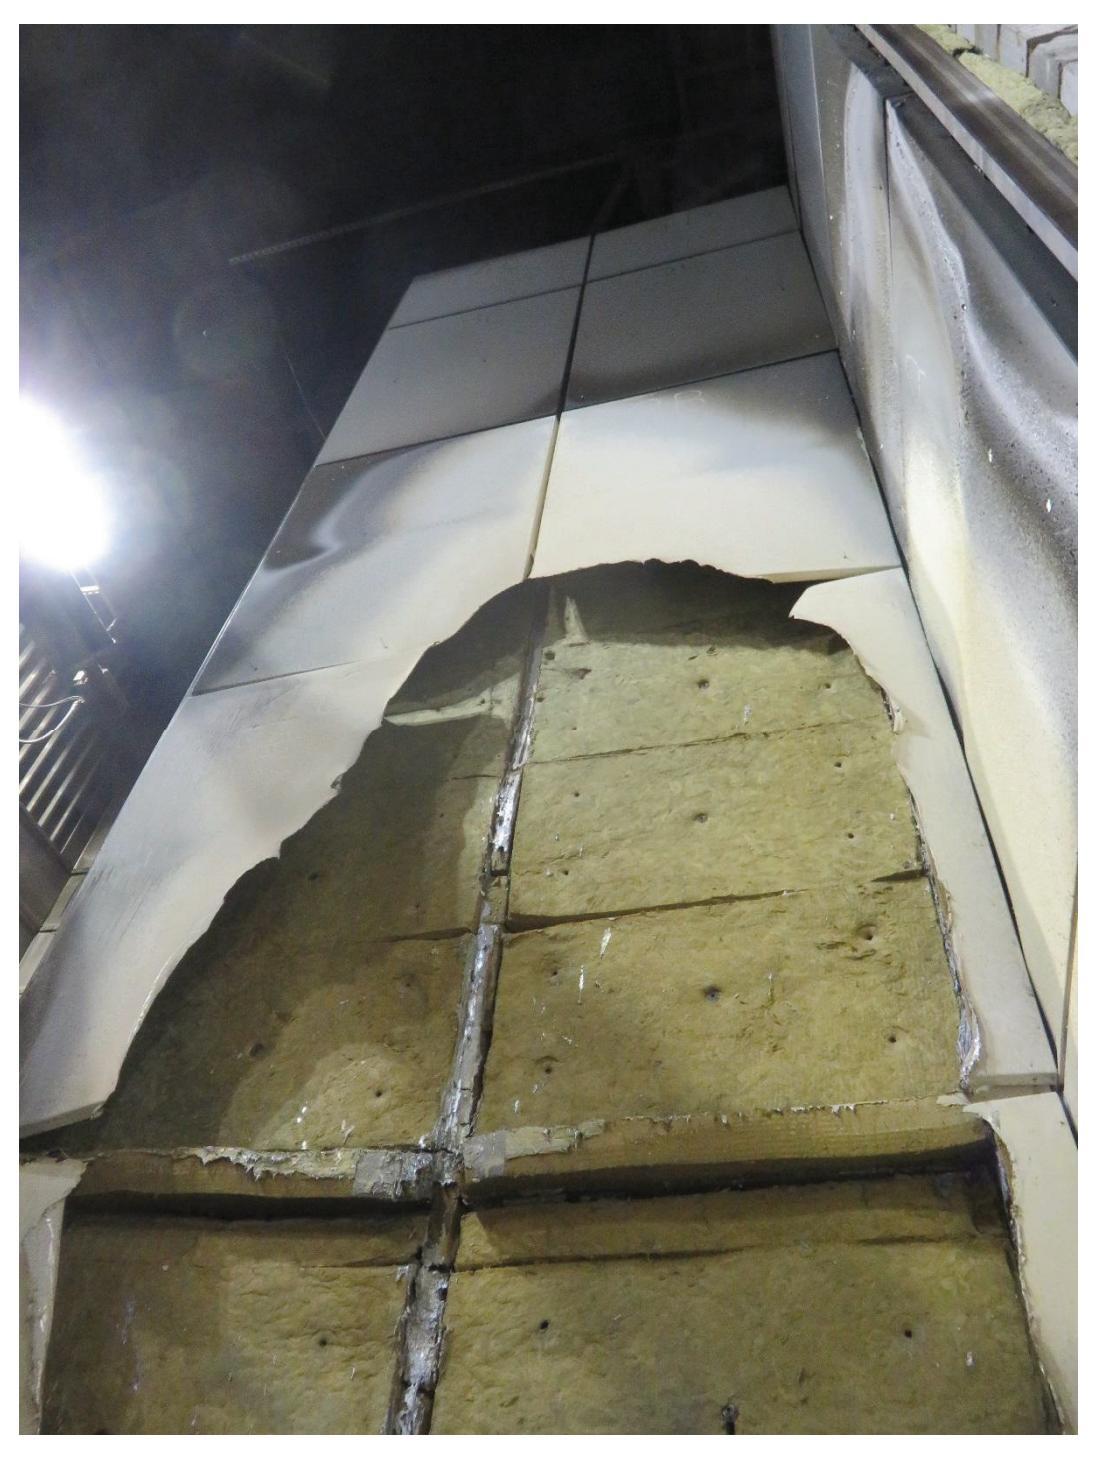
- Panel 0A showed significant distortion with 50% dark discolouration and 50% white discolouration tapering from the top of the panel across approximately 75% of the height.

- Panel 0B was 90% consumed. The remaining panel was discoloured.
- Panel 0C was 30% consumed. Approximately 25% of the panel was discoloured white, the remaining 55% was undamaged.

- Panel 1A was discoloured white across 90% of the surface area and dark discolouration on the rest of the panel. Slight distortion.
- Panel 1B was 90% consumed and discoloured white on the remaining panel.

- Panel 1C was 20% consumed and distorted such that the right-hand edge of the panel tended away from the insulation.
- Panel 2A remained intact but was distorted and discoloured.

- Panel 2B was <10% consumed at the base and with approximately 85% discoloured white and the top right-hand corner discoloured black.
- Panel 2C was <5% consumed at the base (along the centre line of the combustion chamber) with 60% discoloured white where exposed to direct flame impingement and discoloured black at the outside edge.

- Panel 3A was intact with minimal signs of damage.
- Panels 3B&3C was 5% discoloured black at the base (along the centre line of the combustion chamber)

- Panels 4A-4C were intact with no visible signs of damage.

Figure 20. View of main wall panels above the combustion chamber.

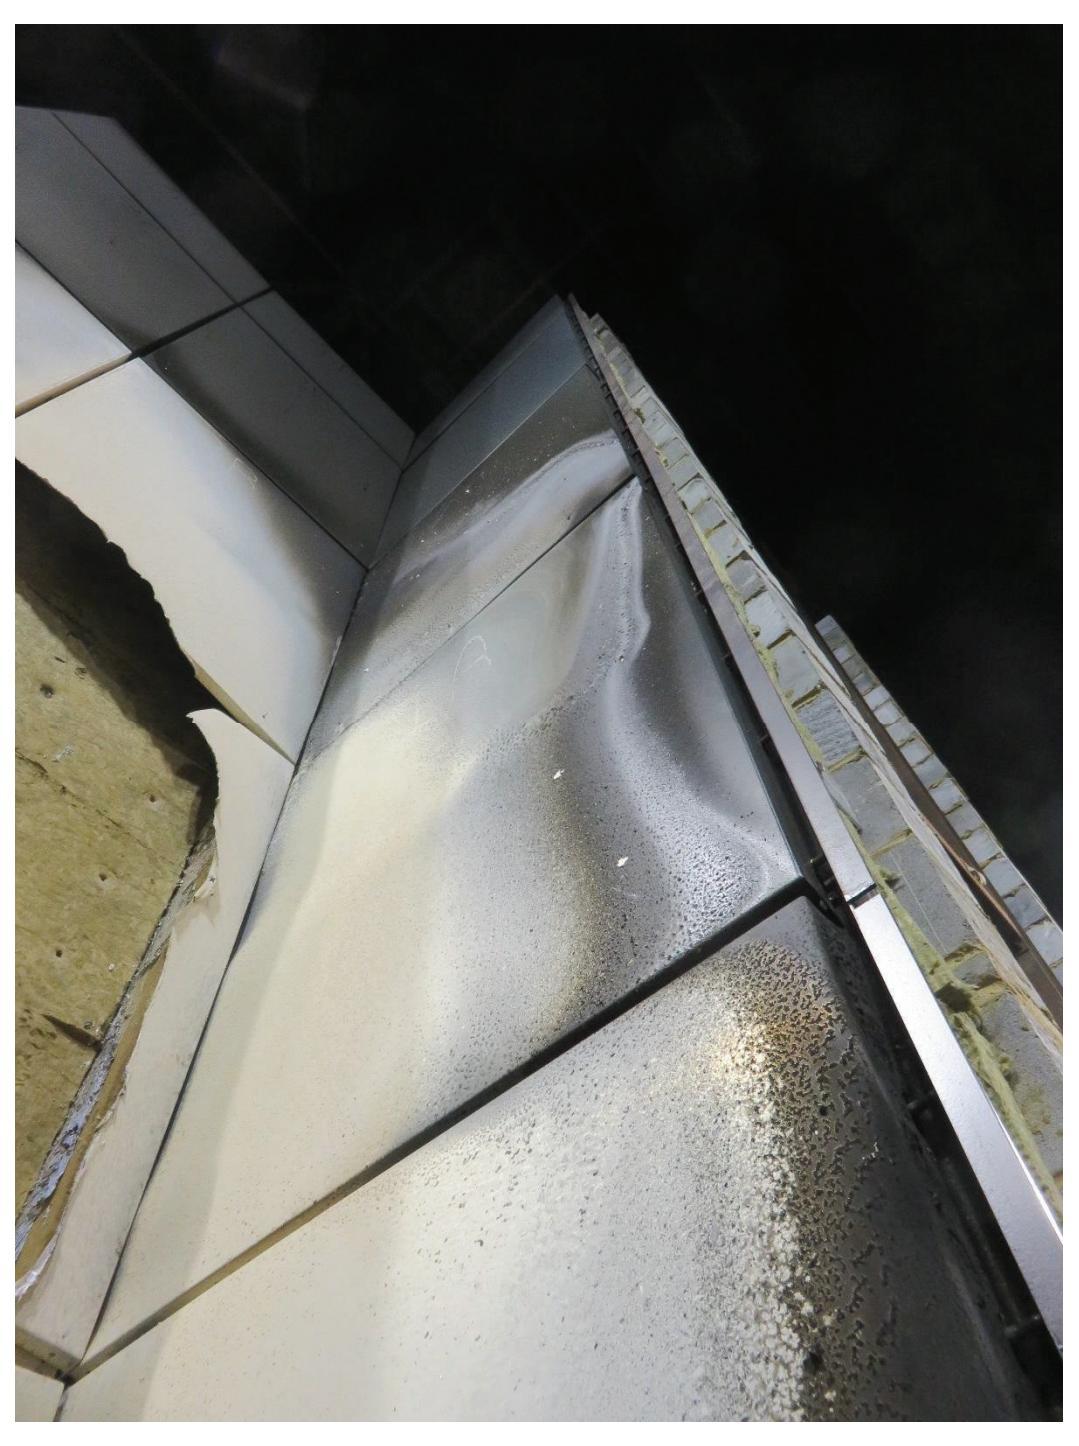
Figure 21. View of wing wall panels above the combustion chamber.

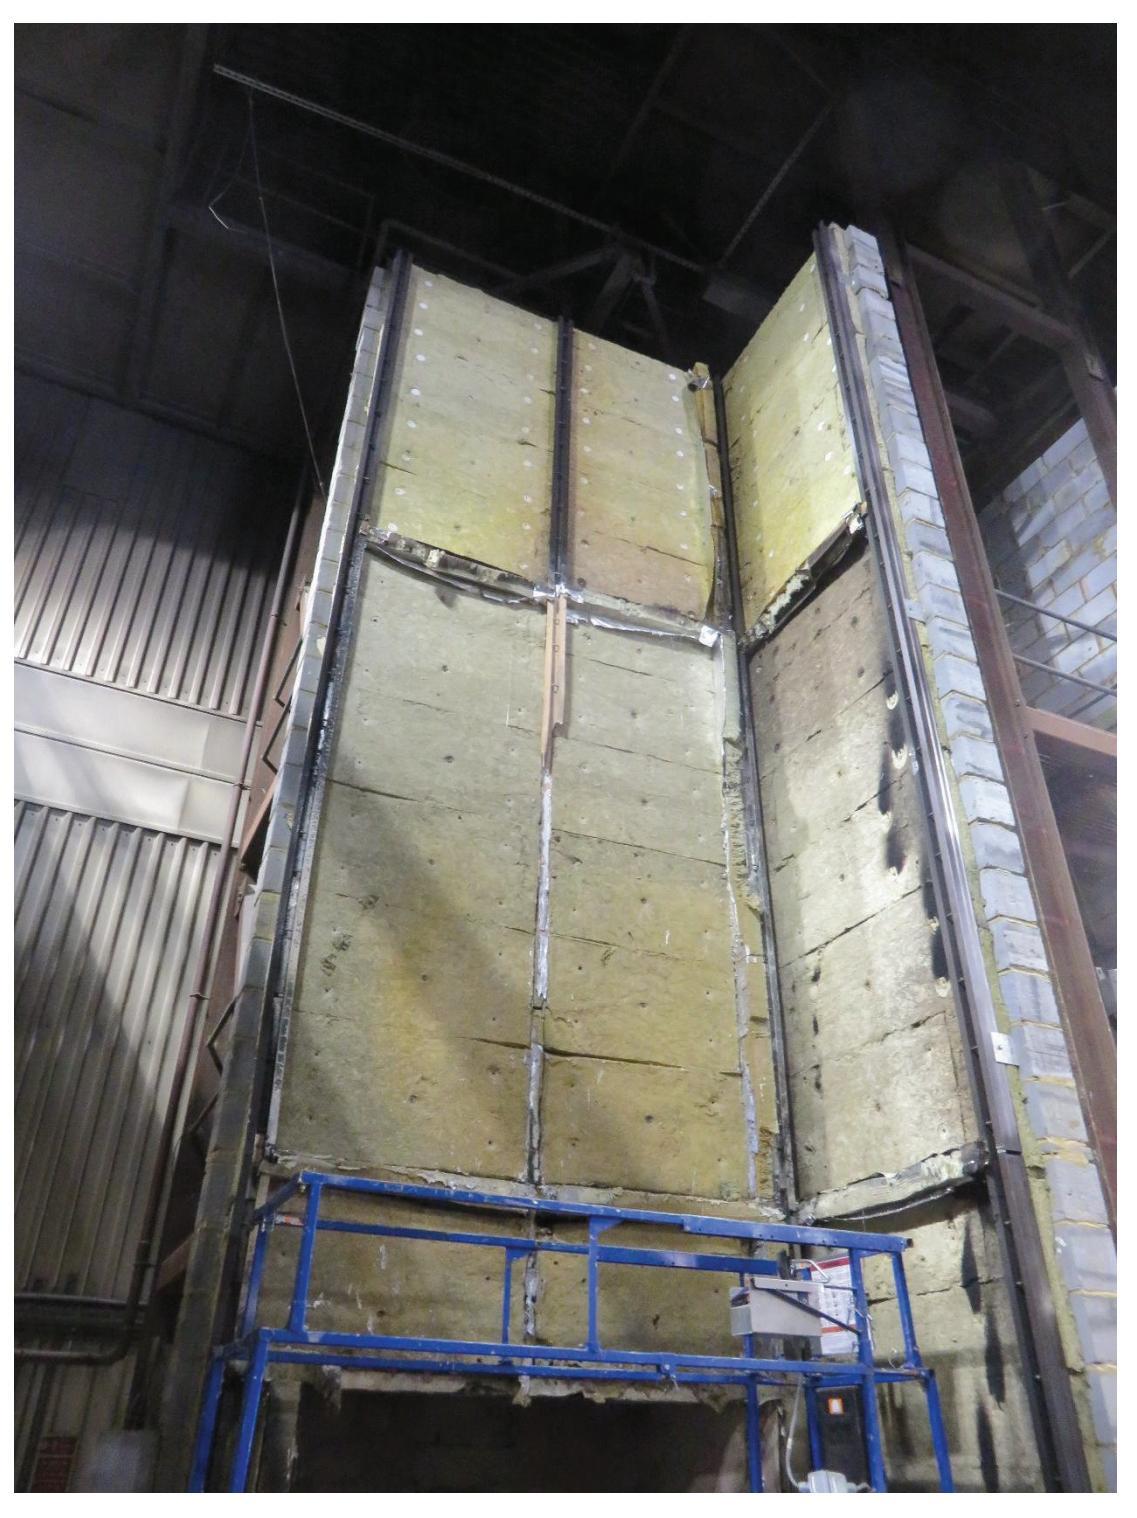
Approximately 25% of the first row horizontal cavity barrier had detached from the main wall. There was aluminium deposited on the cavity barrier from the top hat section rail. On the wing wall a small amount of detachment was observed at the outside edge of the wall – see *Figure 22*.

Figure 22. View of insulation following removal of aluminium panels.

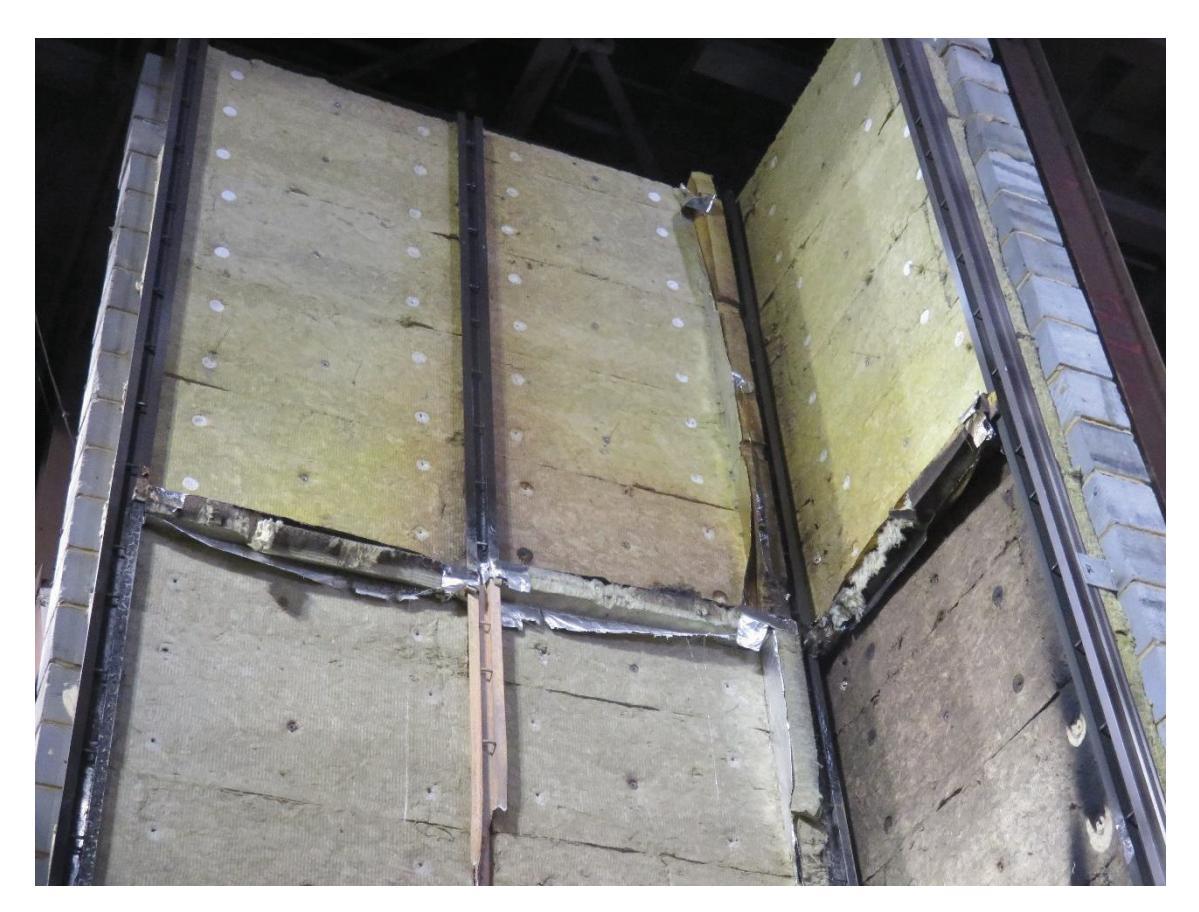
to the vertical cavity barrier. Above the second horizontal cavity barrier some insulation to the right of the central rail was discoloured brown– see *Figure 23*. All plastic insulation fixings were consumed below the height of the second horizontal cavity barrier (approximately 4000mm above the combustion chamber opening).

The second row horizontal cavity barrier was severely damaged. On the main wall, along the centre line of the combustion chamber, there was significant detachment and localised areas of dark discolouration. The significant section of horizontal cavity barrier on the wing wall also detached and was darkly discoloured – see *Figure 23*.

Figure 23. Damage to insulation above the second row of horizontal cavity barrier.

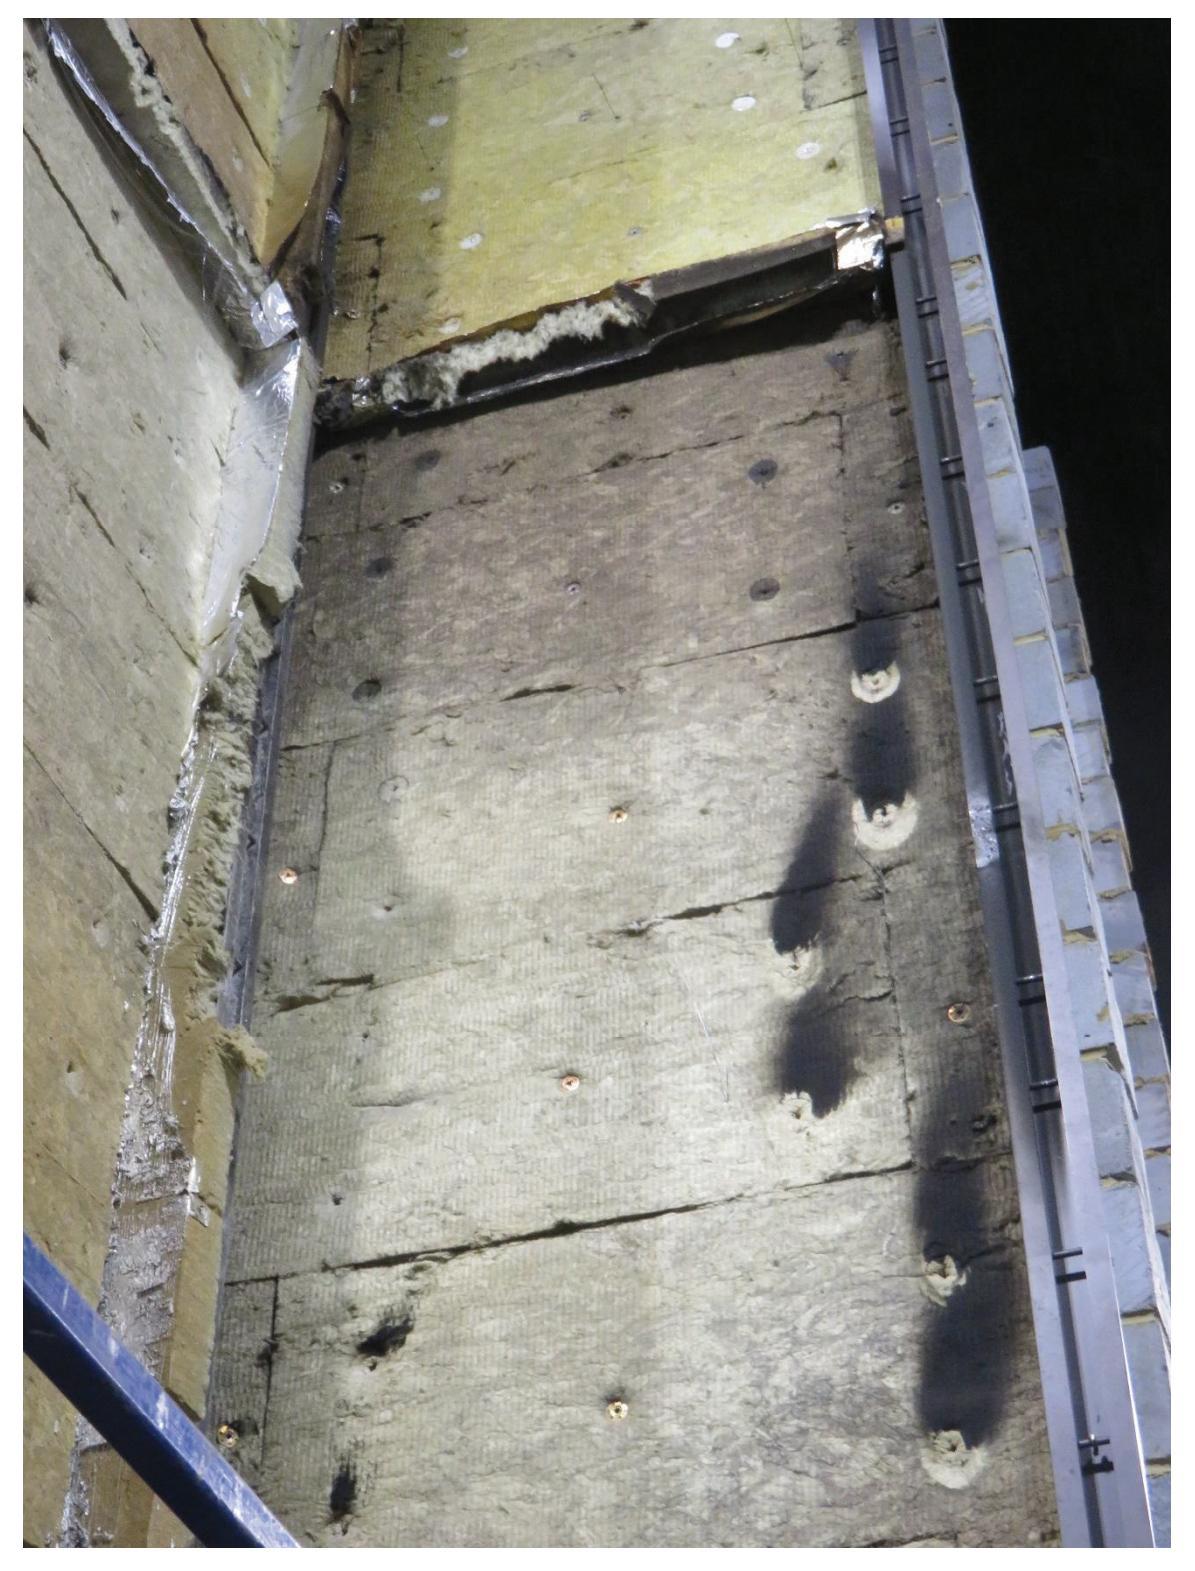
Figure 24. Main-wing wall junction below the second horizontal cavity barrier.
