d+b facades

OVERCLADDING SPECIALISTS

Overcladding, the economic, social and environmentally sound solution to a legacy of **1960's** academic buildings

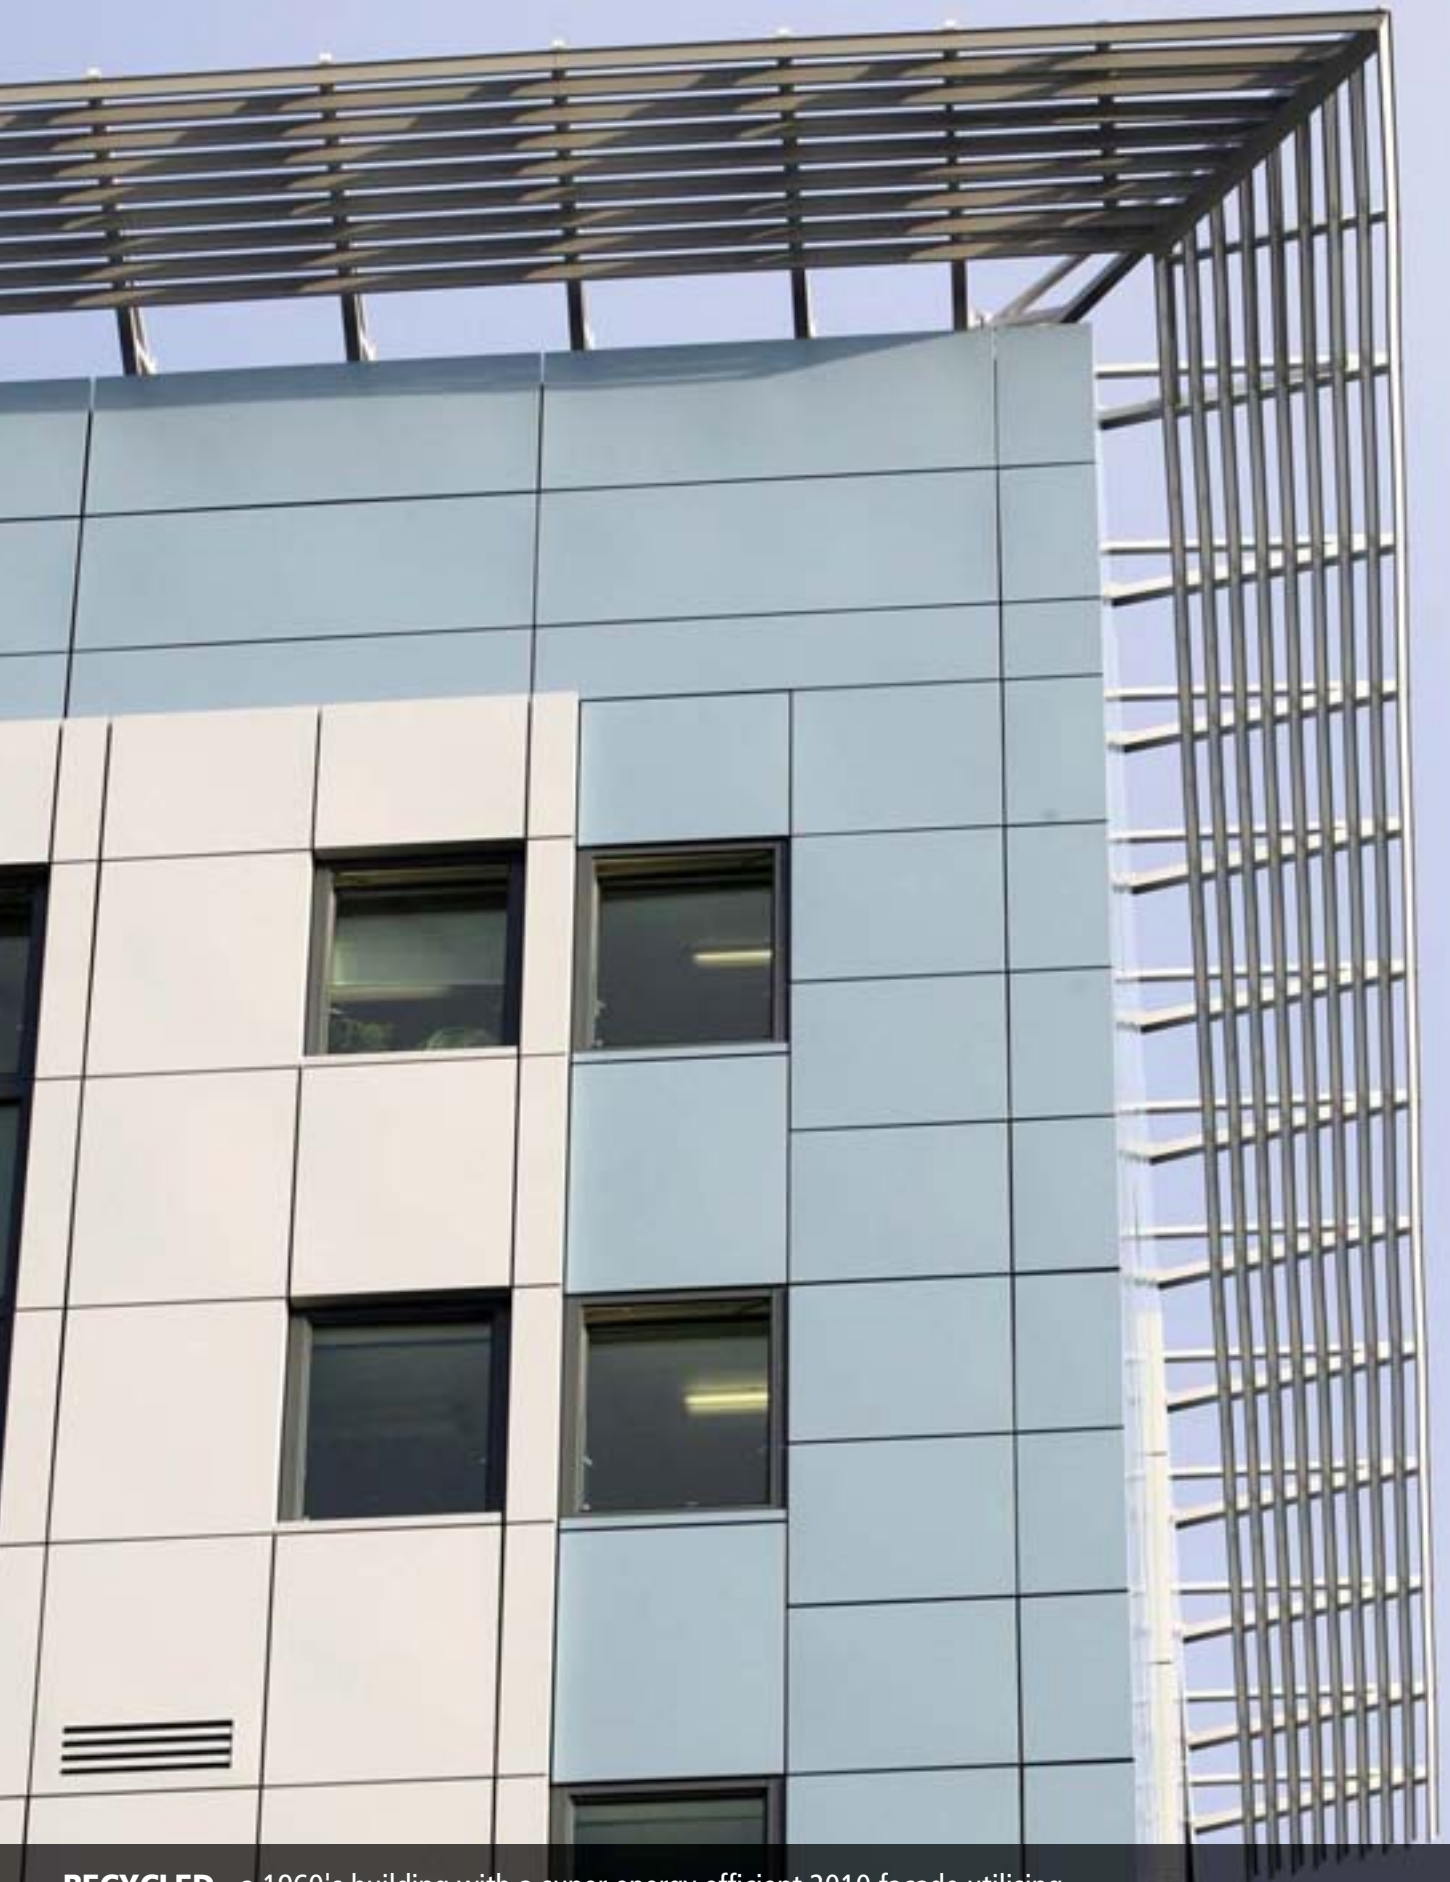
University of Plymouth

RECYCLED - a 1960's building with a super energy efficient 2010 facade utilising 60% recycled materials that are 100% reusable at the end of their 60 year life in 2070.

Aluminium Rainscreen
Window Replacement
Curtain Walling to Stair Towers
Insulation
Concrete Repair
Internal Finishes to Windows

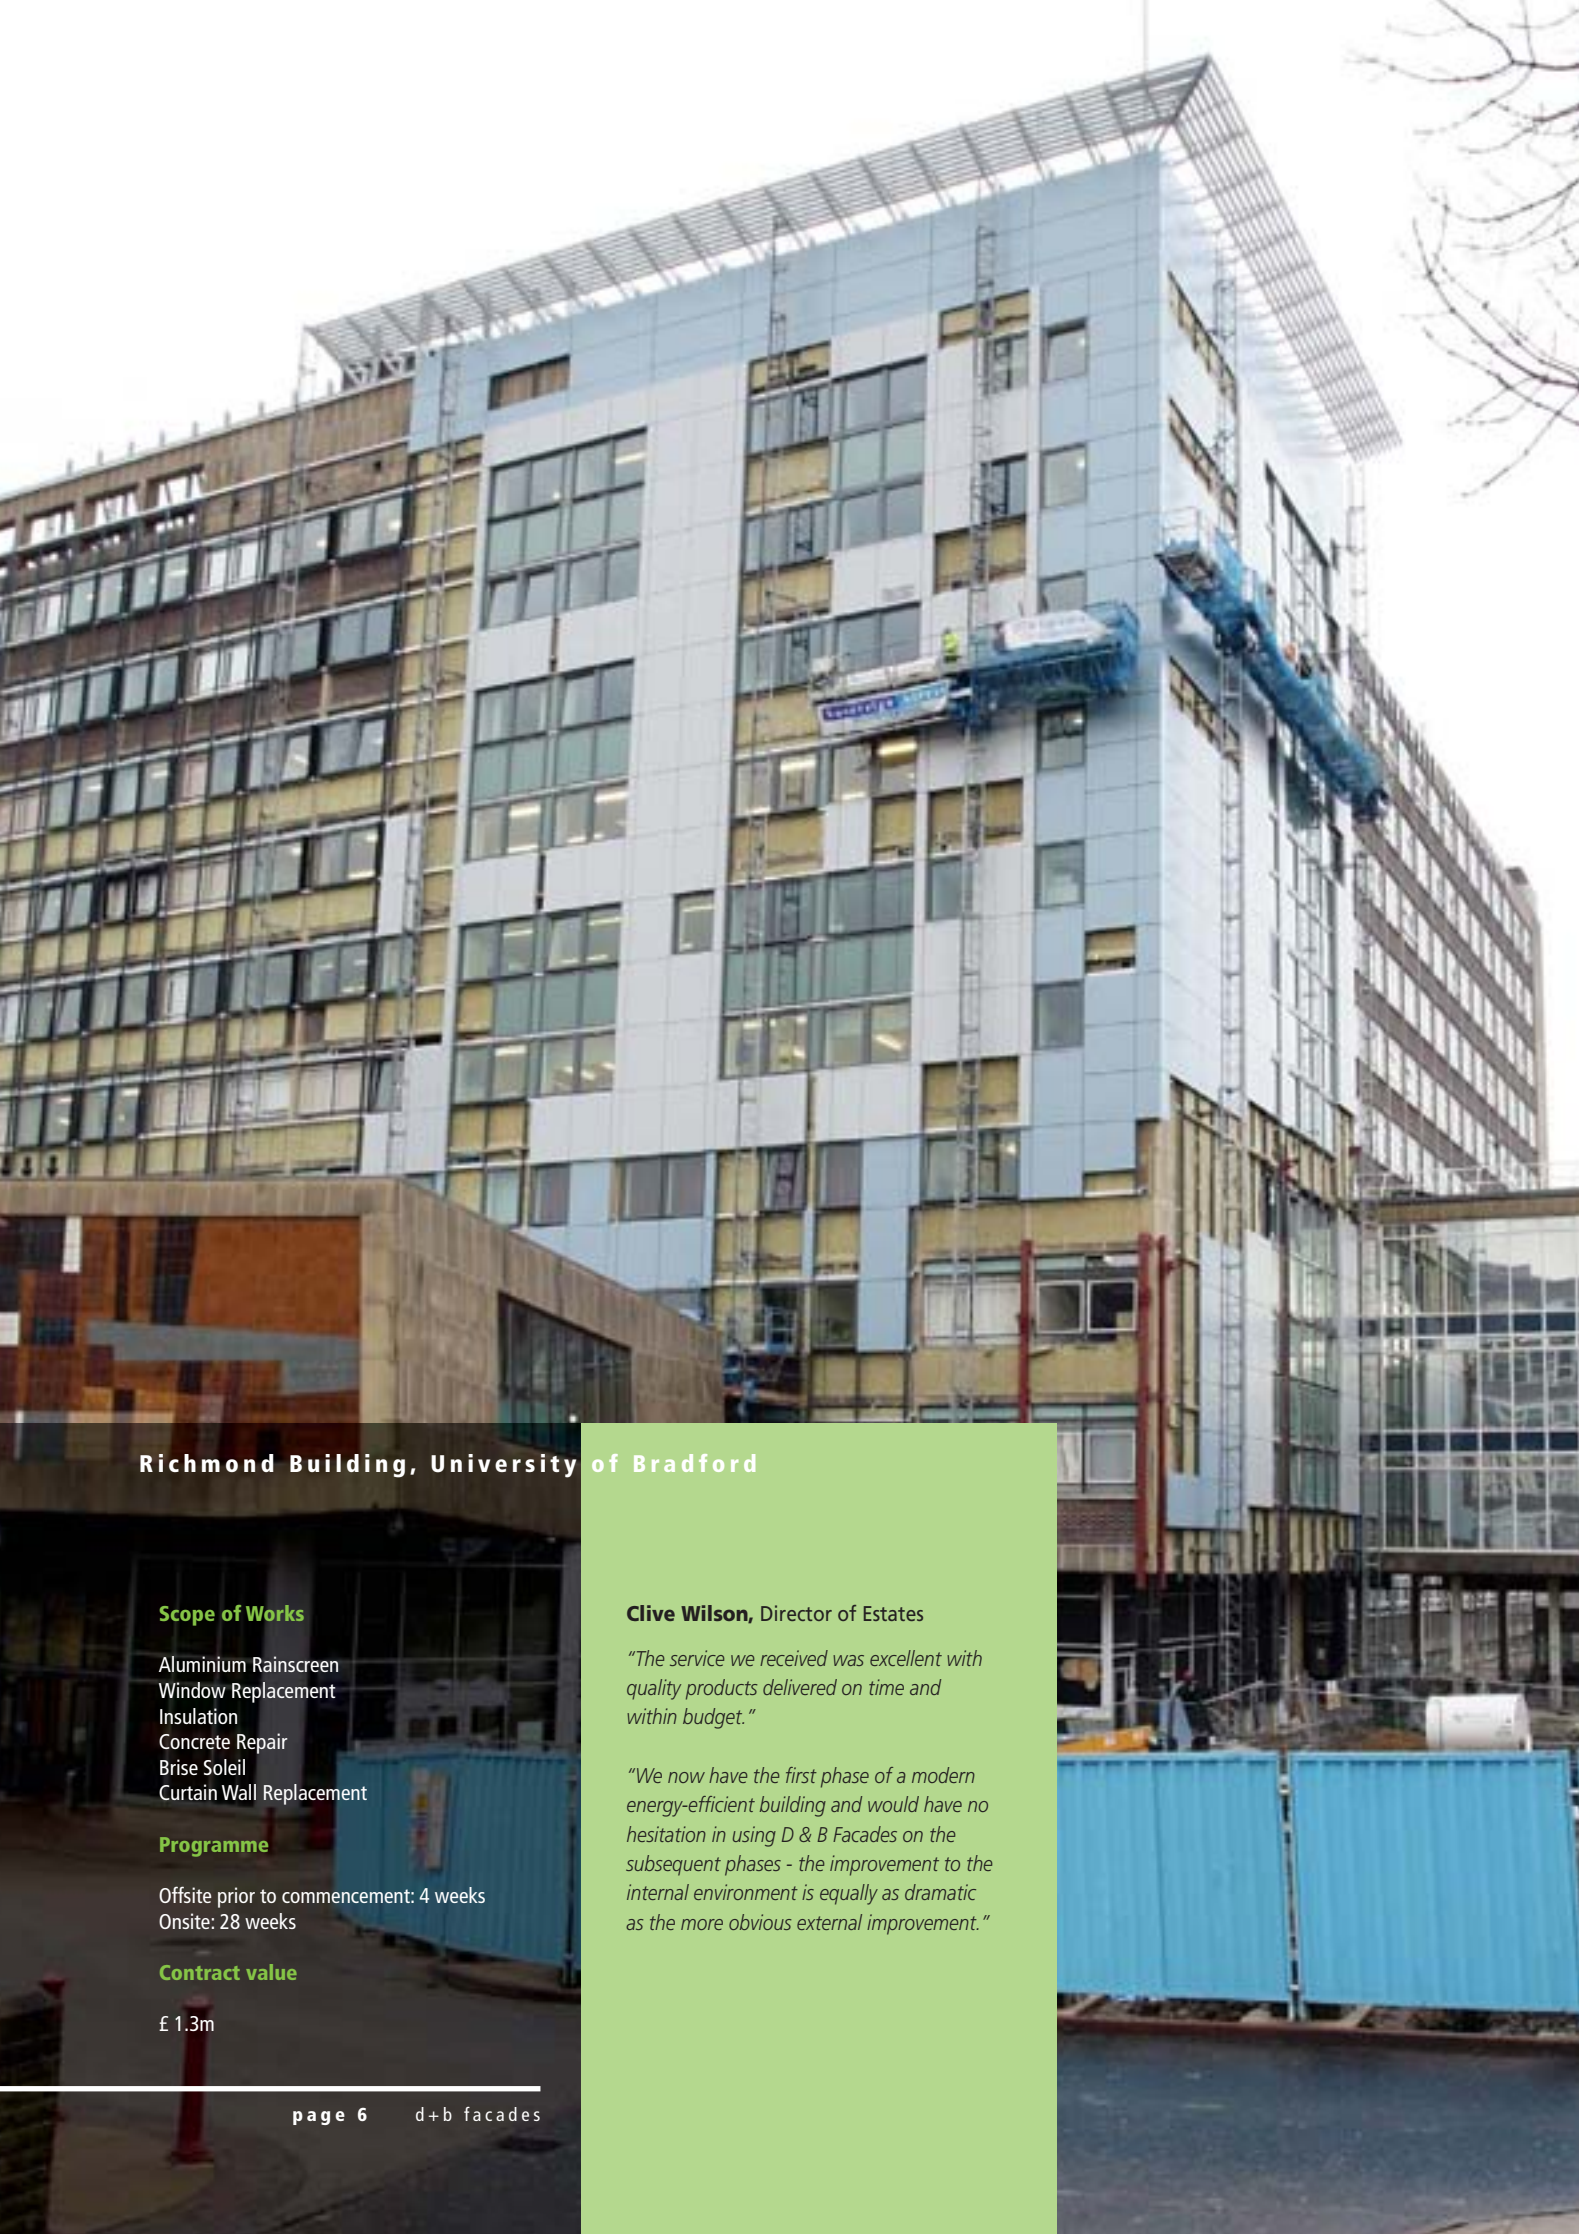
Richmond Building, University of Bradford

Aluminium Rainscreen
Window Replacement
Insulation
Concrete Repair
Brise Soleil
Curtain Wall Replacement

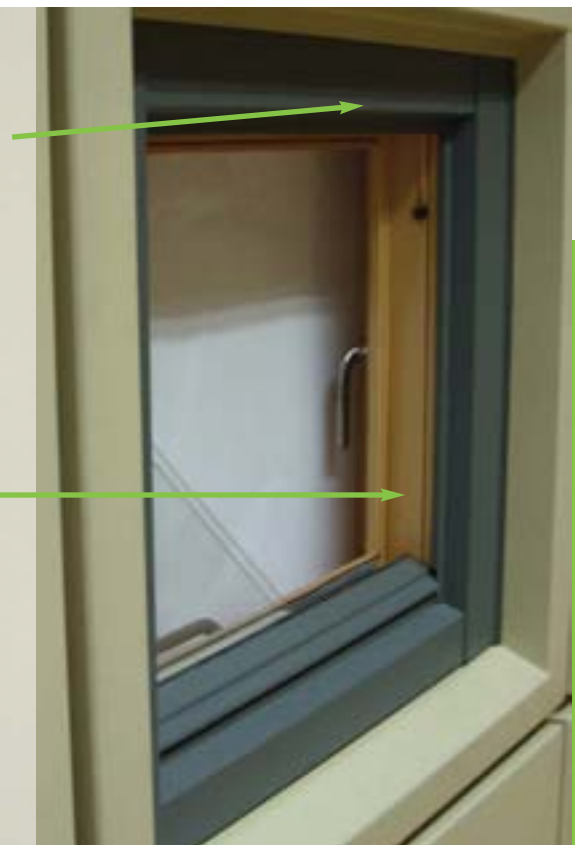
Rainscreen Panel system + Integrated Window

Drained & ventilated aluminium window cladding interlocked with aluminium rainscreen.

Sustainable Tilt/Turn Integral Aluminium Clad Timber Window to achieve 1.2 or 0.7W/m²K.

Insulated Aluminium rainscreen as SK1 to achieve 0.2 W/m²K or 0.1 W/m²K.

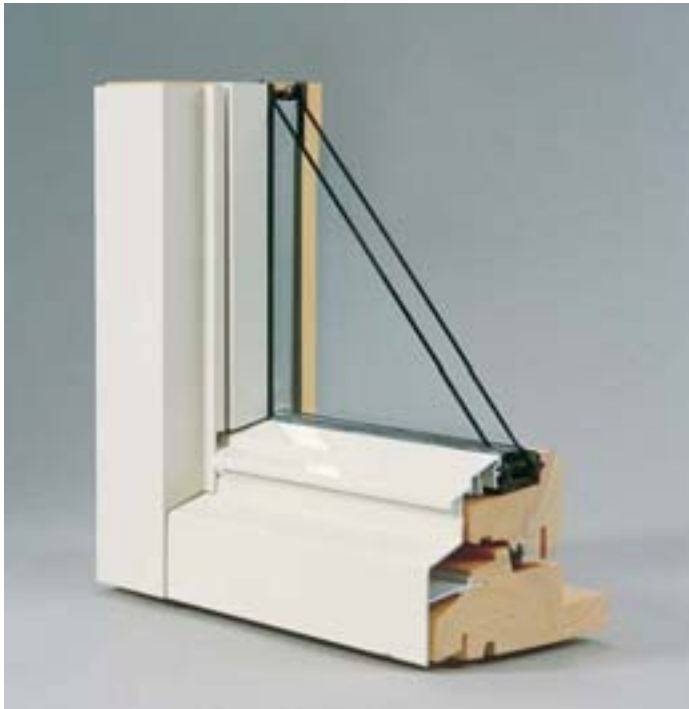
A typical 1960's single glazed window has a u value of 5.0 W/m²K, the current regulations specify 2.0 W/m²K. 0.7 W/m²K is now achievable with today's technology representing a 7 fold improvement. A typical 1960's wall achieves circa 1.37 W/m²K, the regulations today specify 0.3 W/m²K and 0.18 W/m²K is readily achievable, again representing a 7 fold improvement.

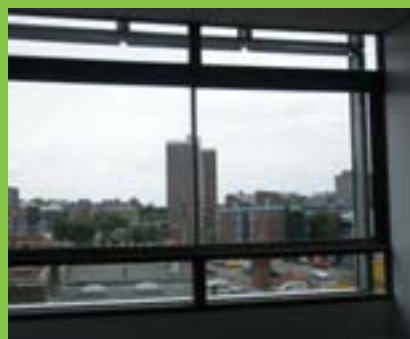
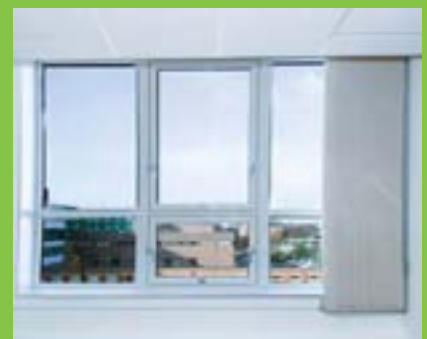
Before and after window replacements at Ellison Building, University of Northumbria. Transforming the internal work space with improved ventilation, solar, thermal and acoustic control.

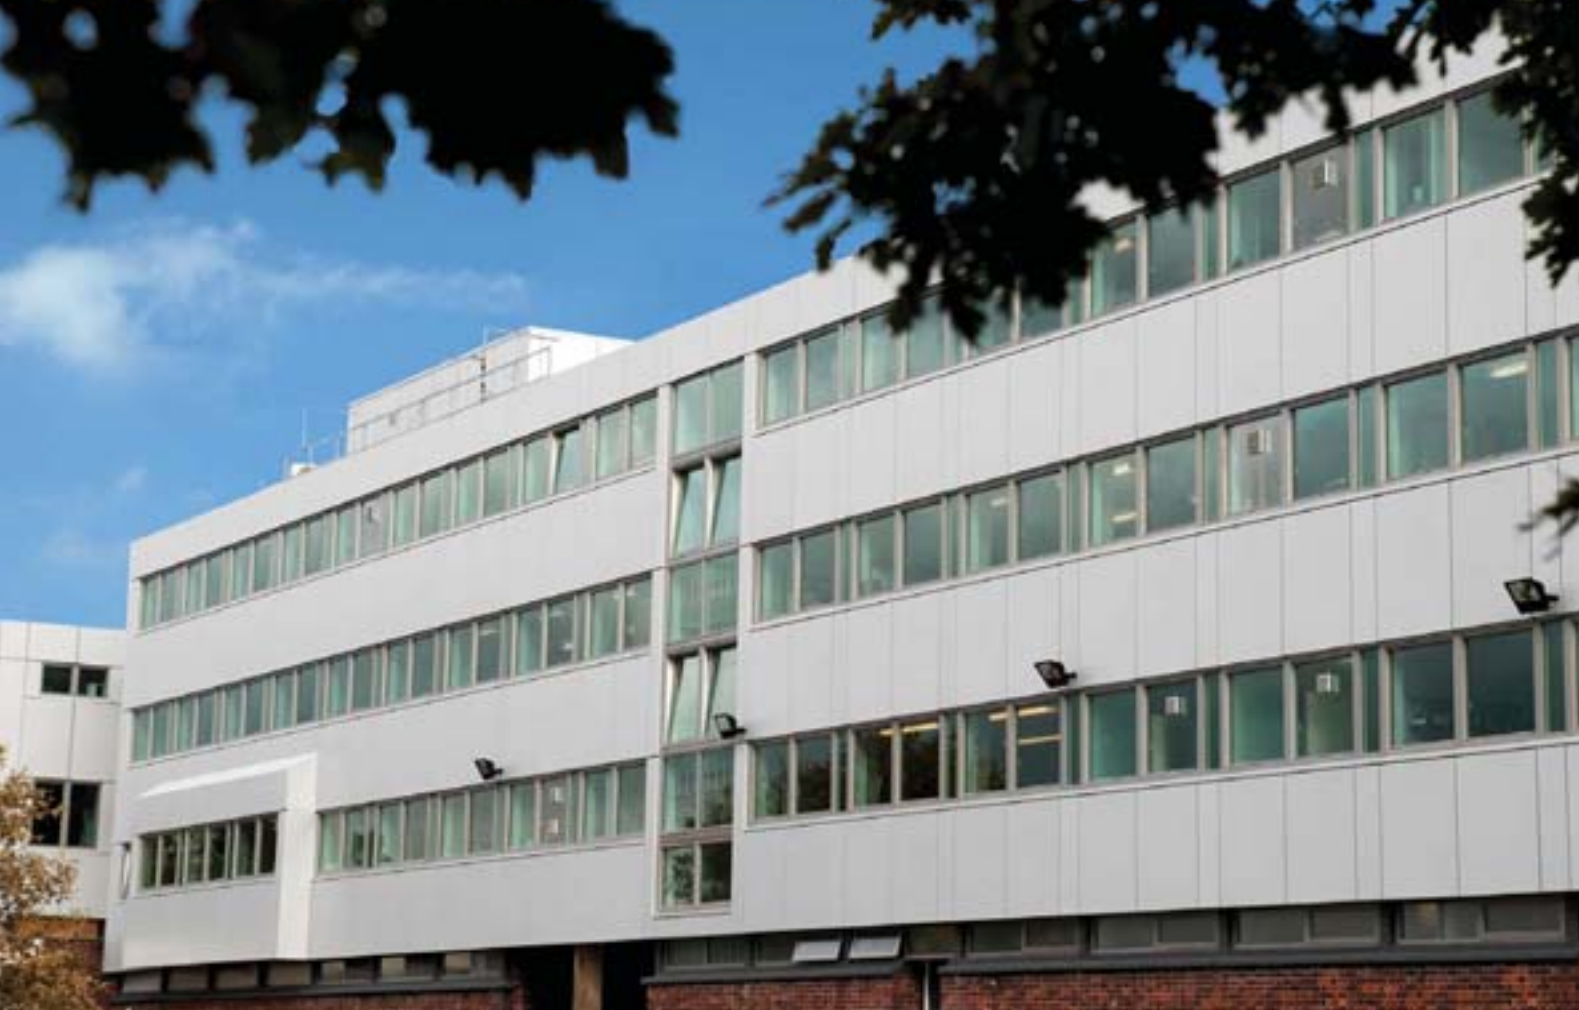
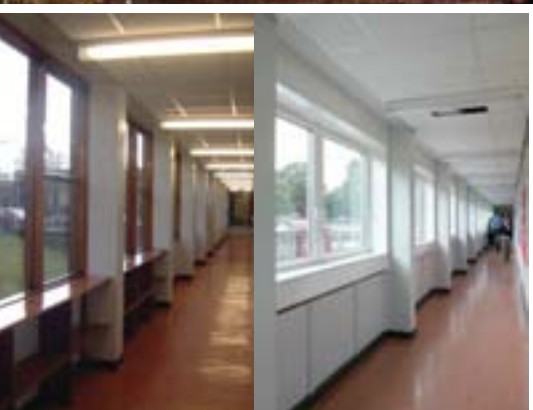
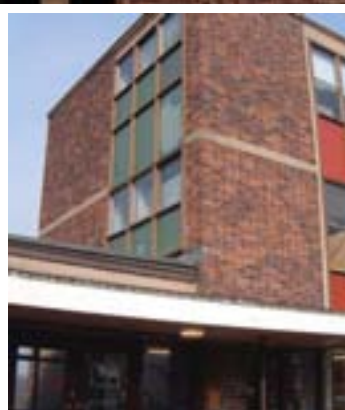
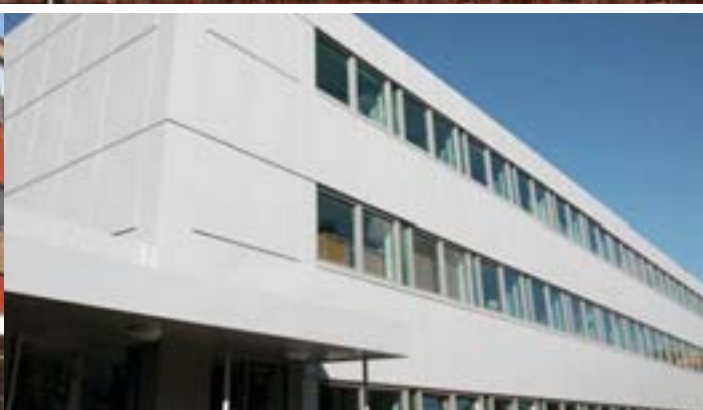
Marple Hall School, Stockport

Aluminium rainscreen
Window Replacement
Insulation
Concrete Repairs
Curtain Walling to Stair Tower
Curtain Walling to Entrance Screen

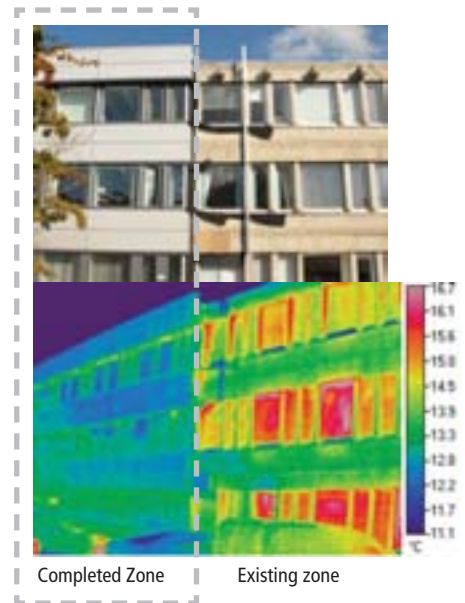
The University of Stirling commissioned a thermal imaging survey of the works whilst they were in progress, and the thermal photograph illustrates the improvement in energy efficiency achieved.

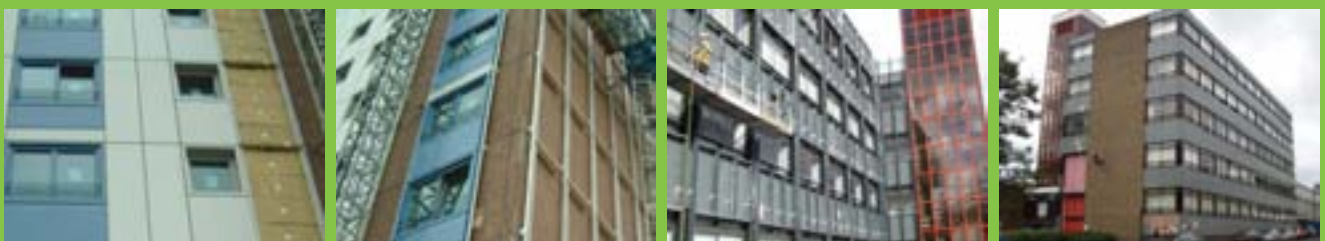
The existing building is wrapped with an insulation blanket up to 200mm thick, prior to overcladding. The end result is a new, super energy efficient building that surpasses current regulations by up to 50%, slashing energy consumption and carbon emissions.

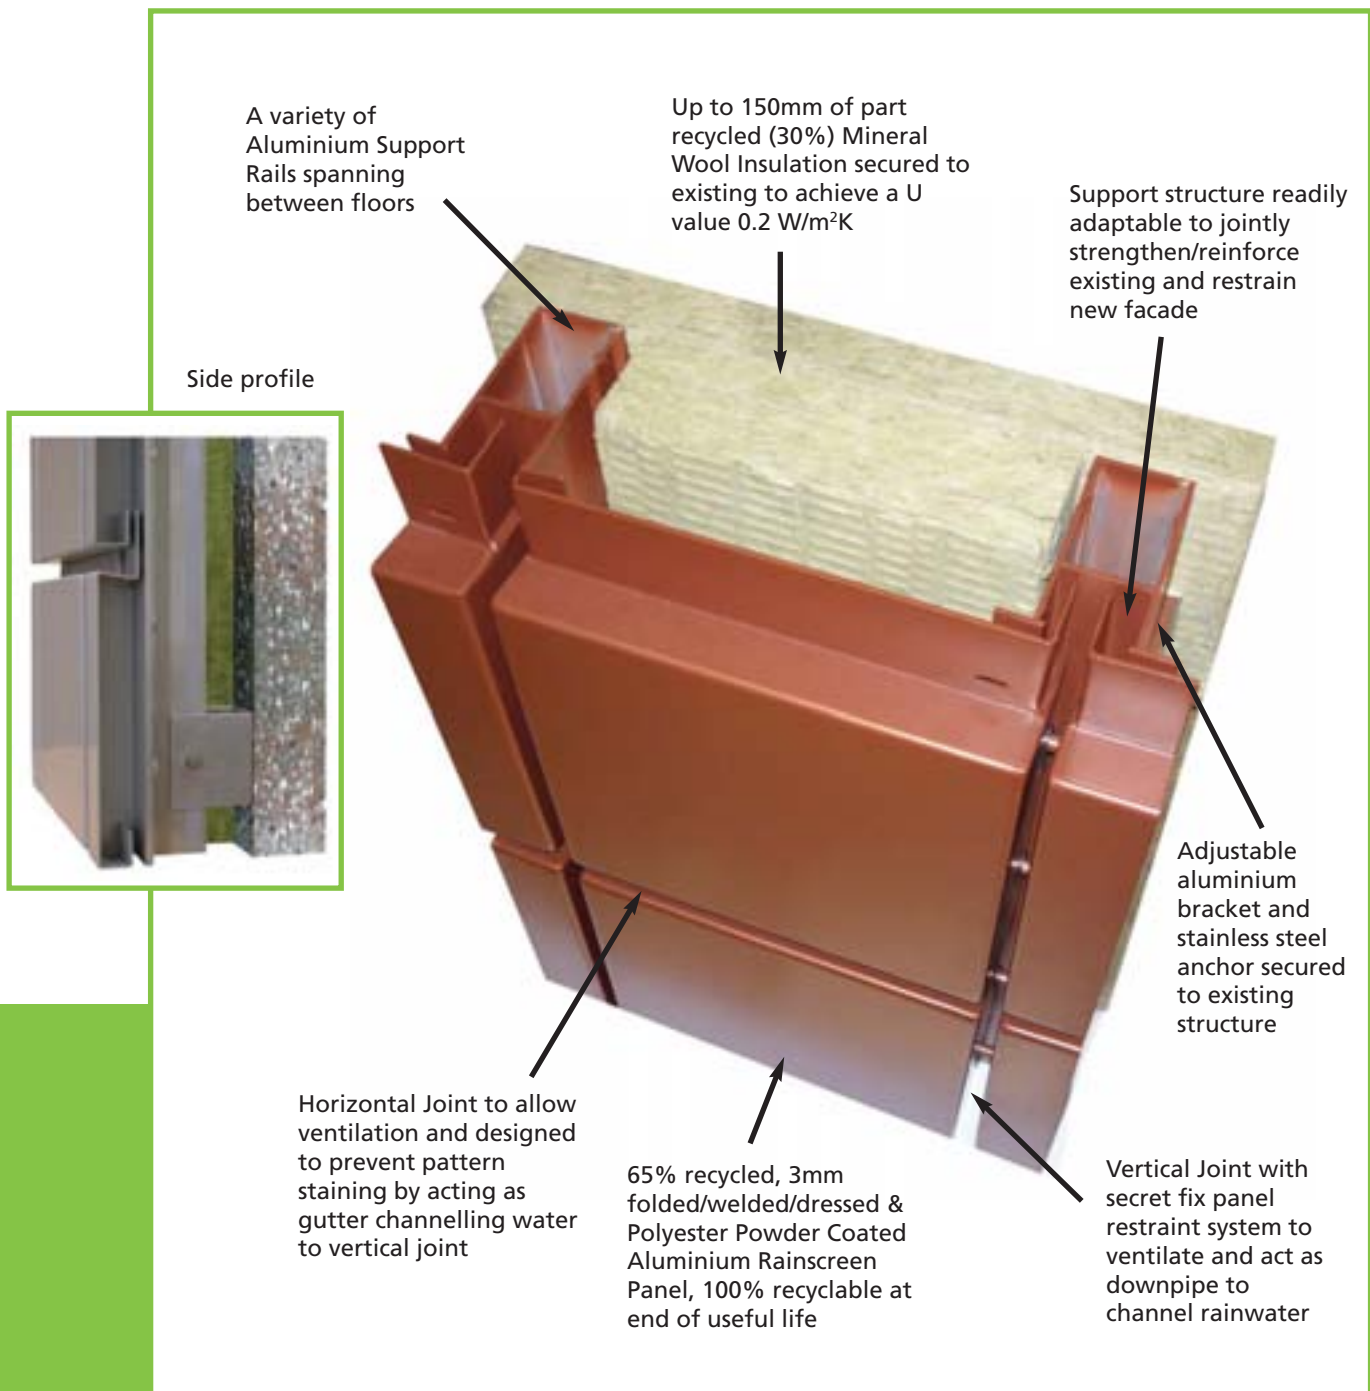
Rainscreen Panel System

60% Part recycled material + 60 yr life + 100% reusable

- General Description; Panels with Modelling and Joint Details to prevent pattern staining are manufactured from 3mm aluminium, fully welded & dressed prior to powder coating, secretly hung/supported on an aluminium framework secured by stainless steel connections to the existing structure. High performance windows are fully integrated utilising aluminium window pods. Interface connections to adjacent systems/curtain walls made using proprietary extrusion profiles.

added to provide additional restraint from uplift. This system allows each panel to be individually removed or replaced quickly and simply if necessary. Cassette Panels are fully welded to form a diaphragm construction.

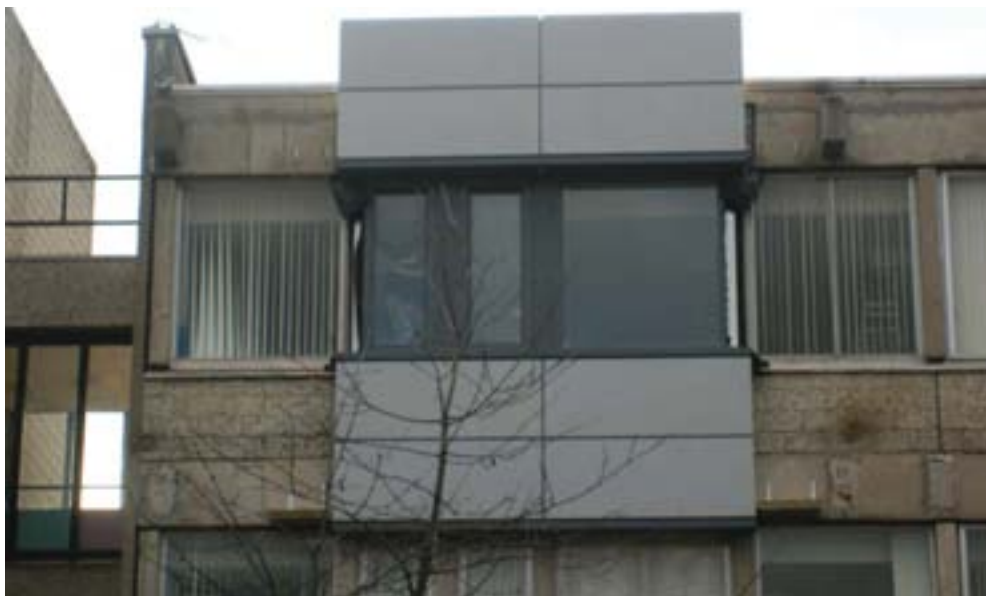
Design Drawings and Mock-up for University of Stirling

On site mock up constructed outside of the Director of Campus Services office

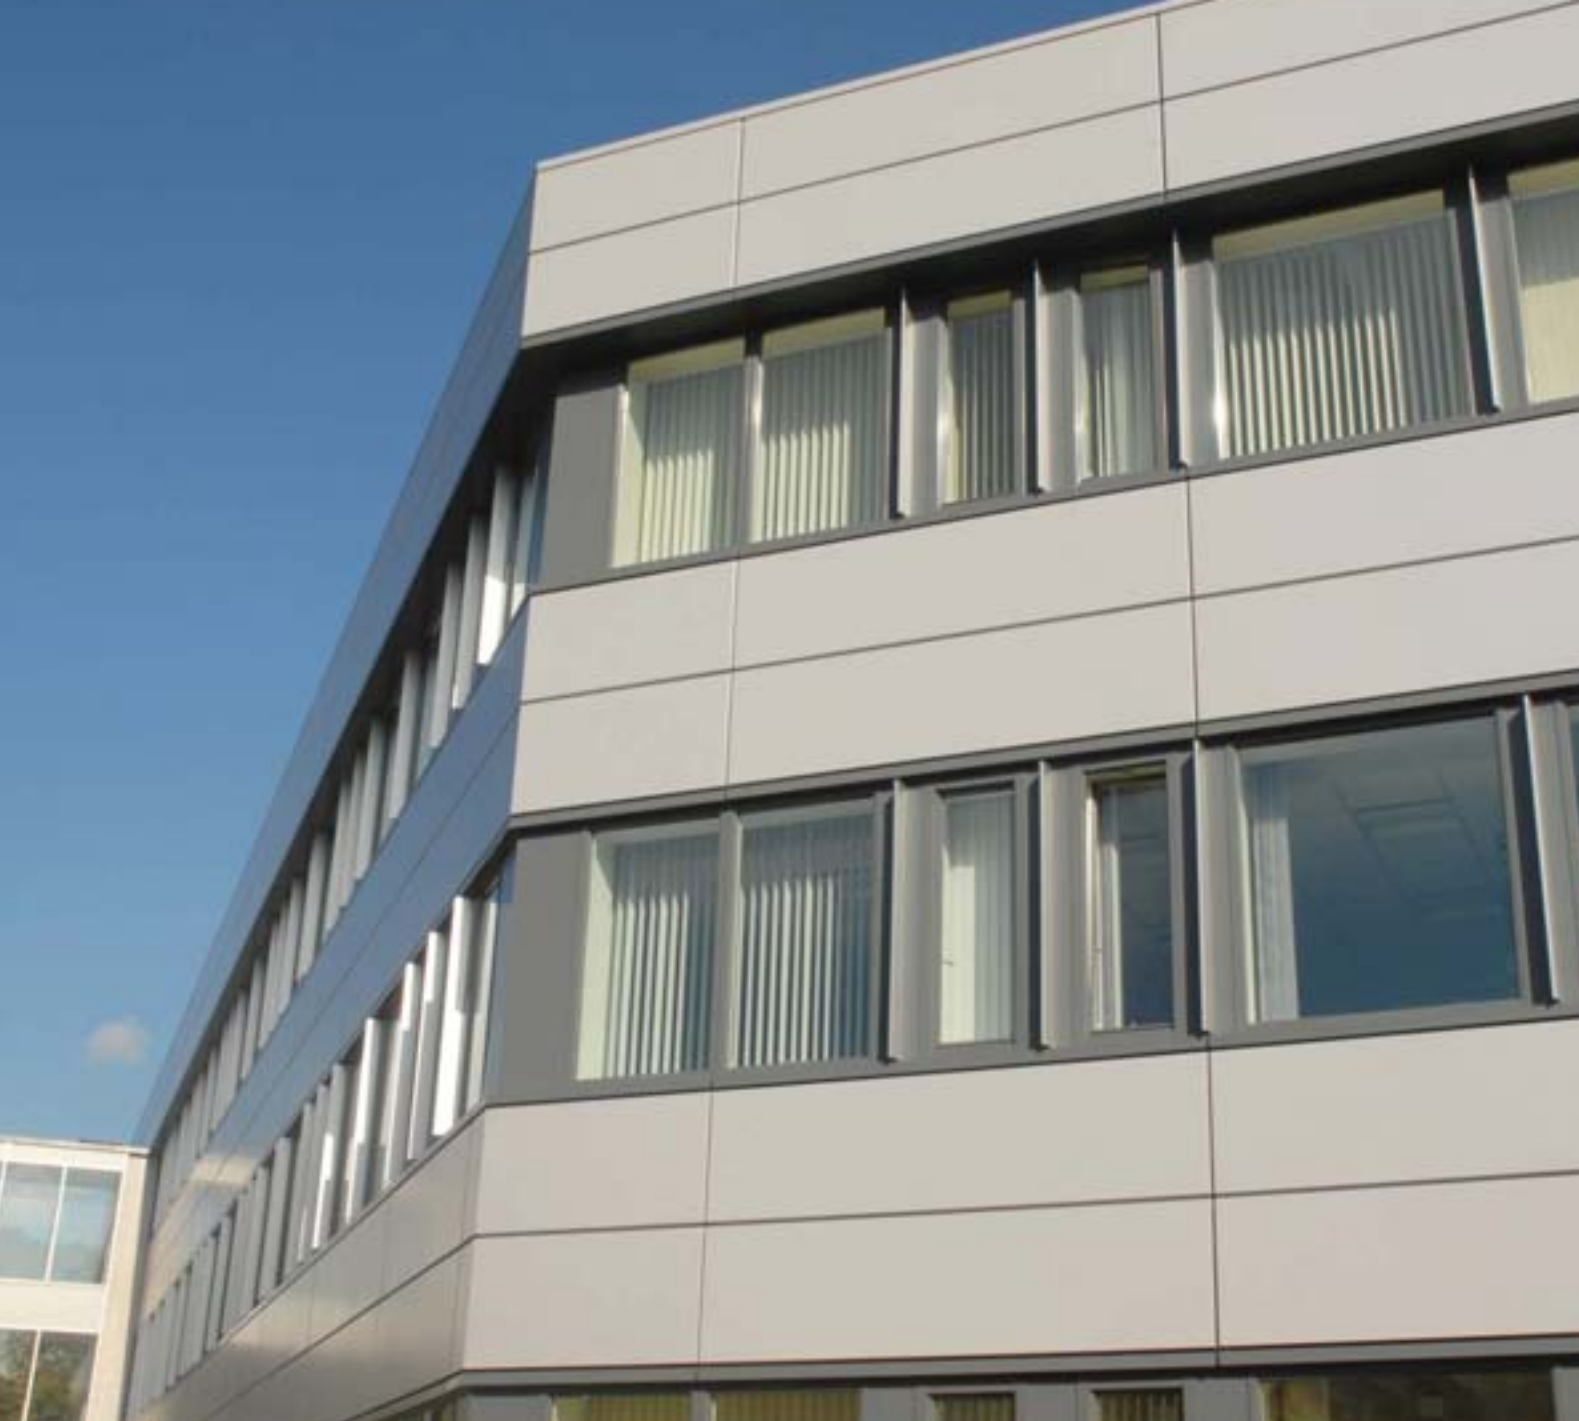
Cottrell Building University of Stirling

Aluminium Rainscreen
Window Replacement
Insulation
Concrete Repairs

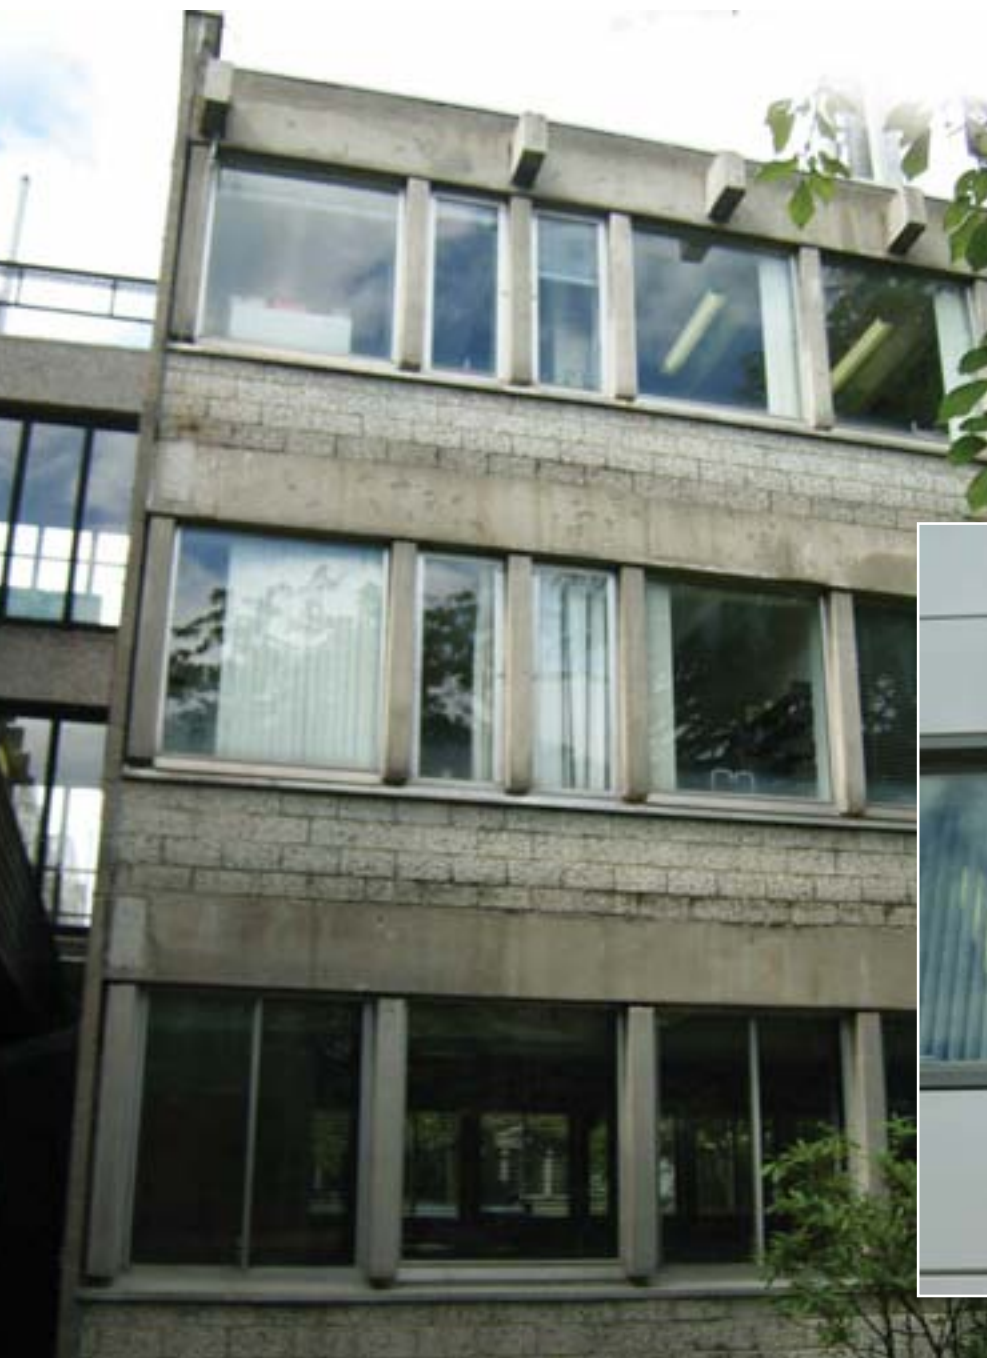
Recycled

A 1960's building nearing the end of its useful life regenerated for use until the 2060's
