Title: Weathertightness testing a rainscreen system for D & B
 Facades

Report No: N950-17-17368

Title: Weathertightness testing a rainscreen system for D & B Facades

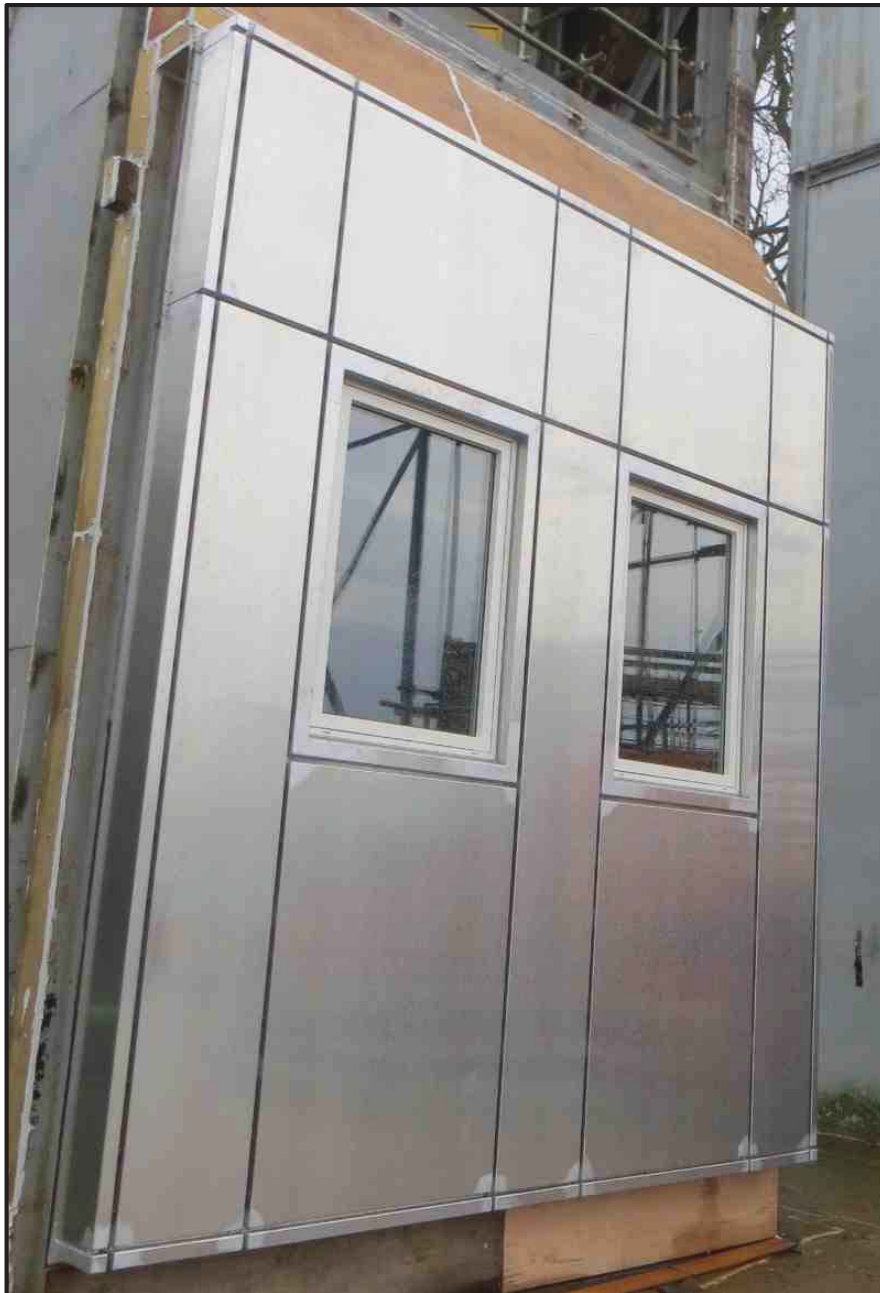
PHOTO 4669

The sample contained two double glazed opening vents and aluminium rainscreen panels mounted on an aluminium frame.

TEST SAMPLE ELEVATION

The sample was as shown in the photo below and the drawing included as an appendix to this report.

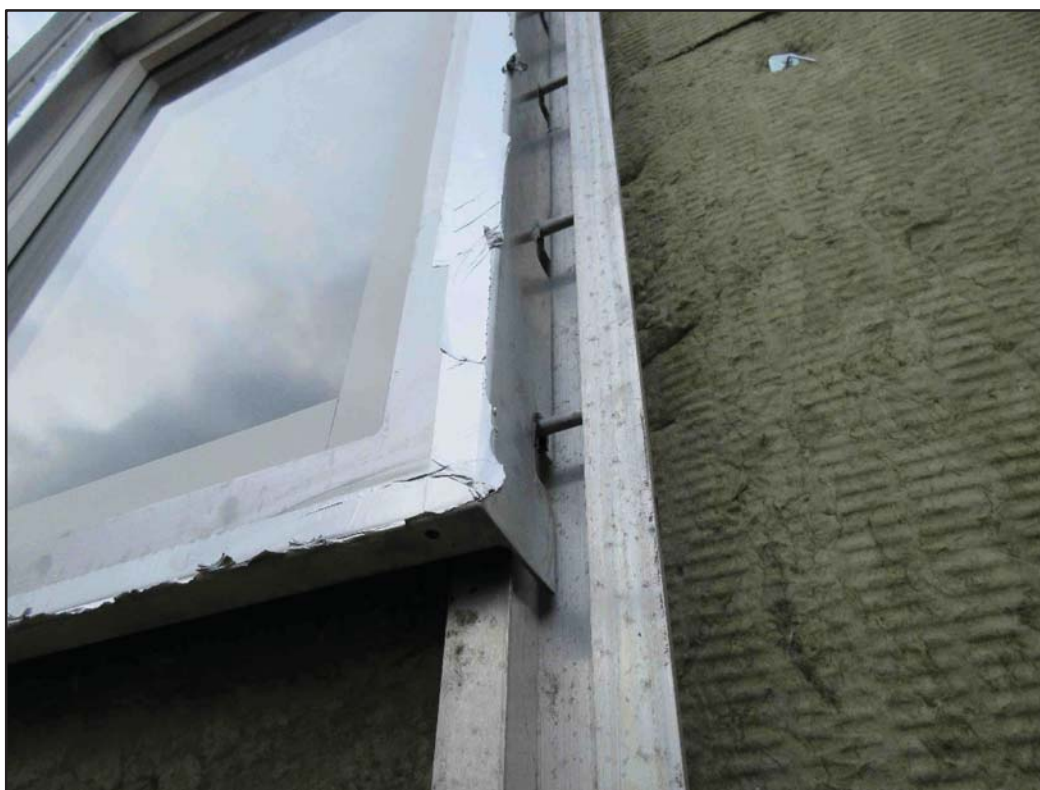
PHOTO 0003

TEST SAMPLE DURING DISMANTLE

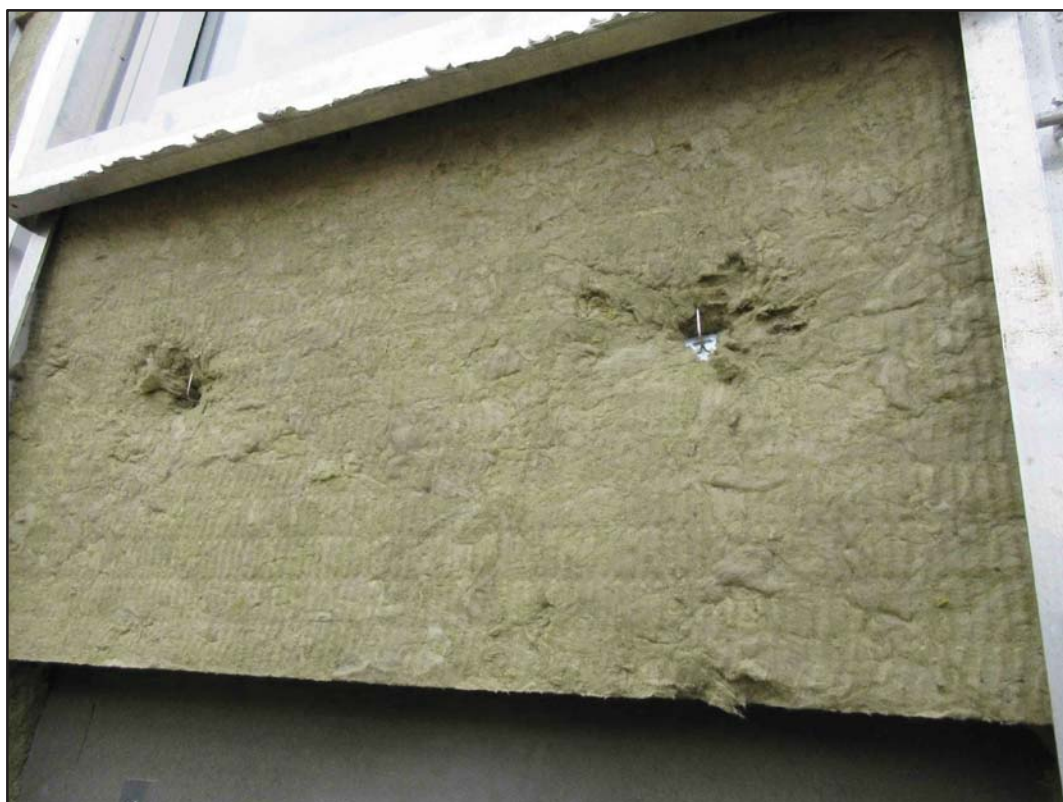
PHOTO 0004

TEST SAMPLE DURING DISMANTLE

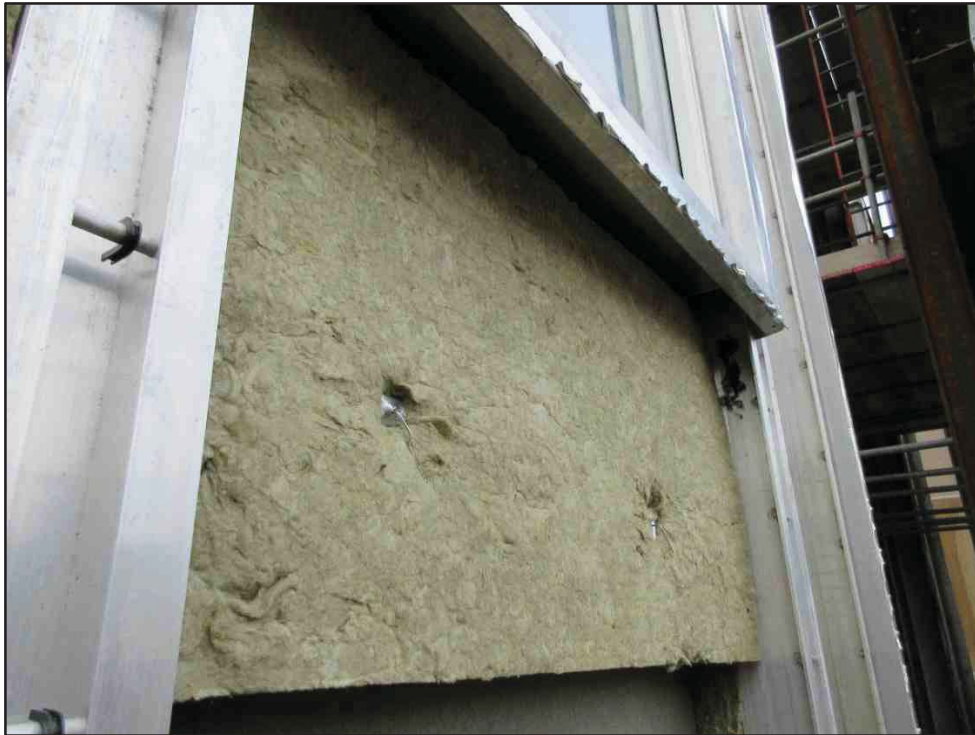
PHOTO 0005

TEST SAMPLE DURING DISMANTLE

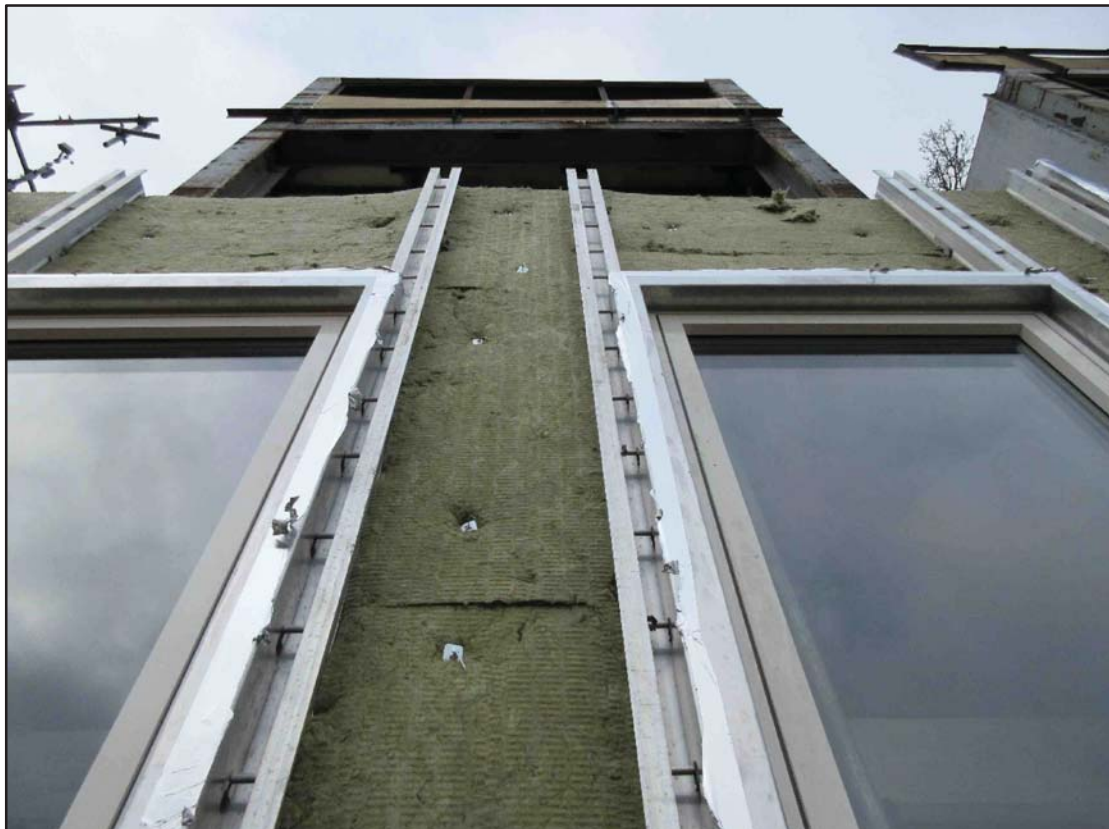
PHOTO 0006

TEST SAMPLE DURING DISMANTLE

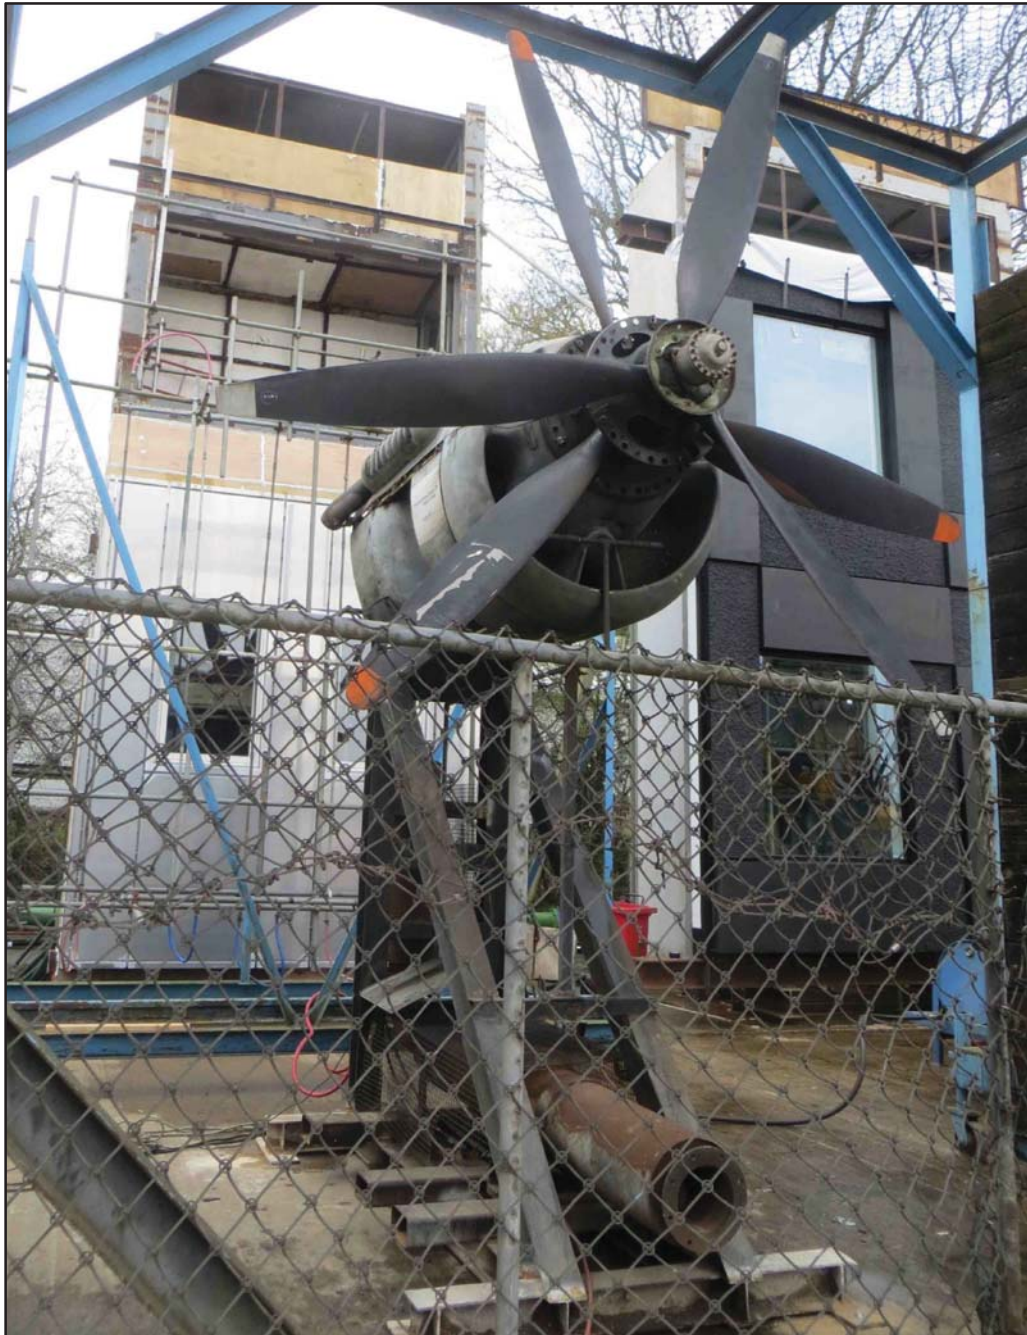
PHOTO 4689

A wind generator was mounted adjacent to the external face of the sample and used to create positive pressure differentials during dynamic testing. The wind generator comprised a piston type aero-engine fitted with 4 m diameter contra-rotating propellers.

DYNAMIC WIND GENERATOR

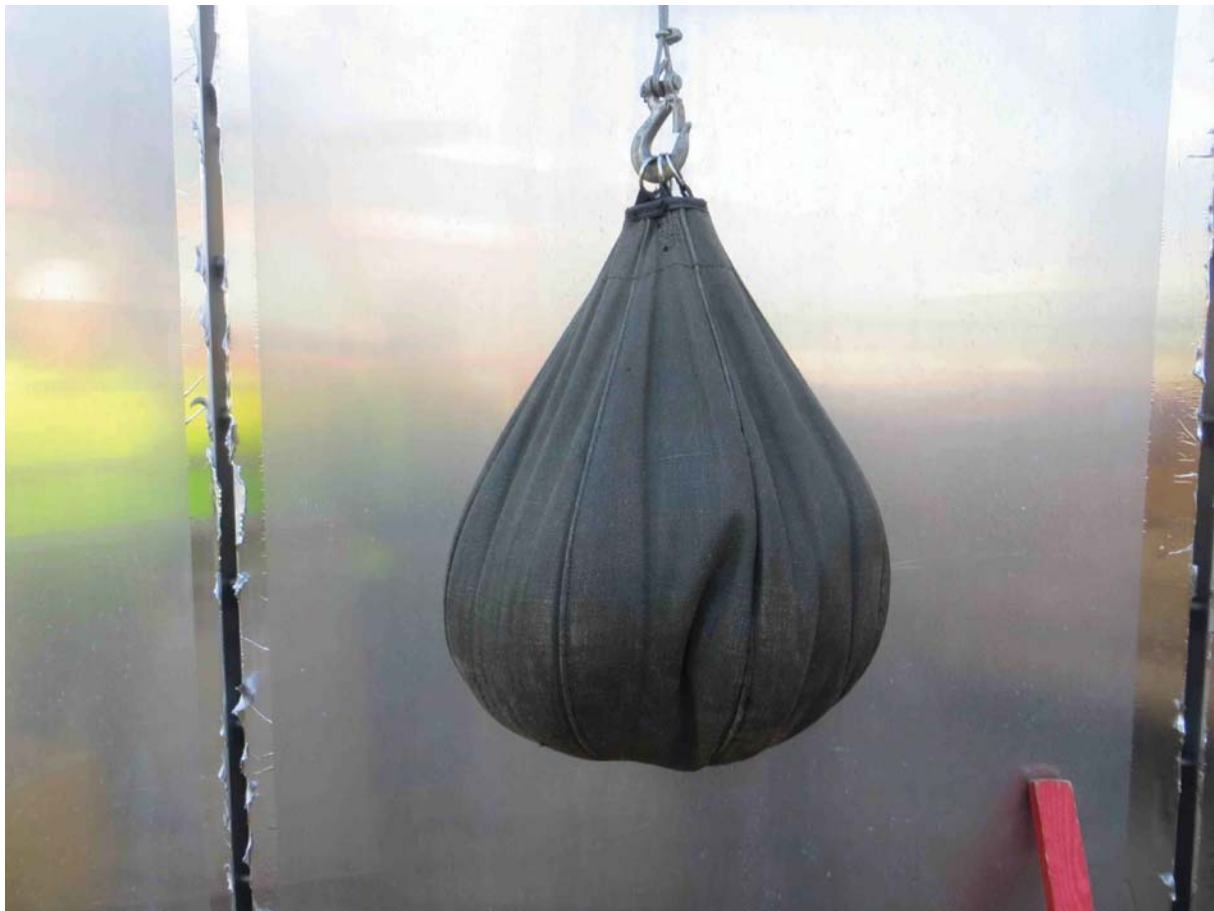
PHOTO 4701

The soft body impactor comprised a canvas spherical/conical bag 400 mm in diameter filled with 3 mm diameter glass spheres with a total mass of approximately 50 kg suspended from a cord at least 3 m long.

SOFT BODY IMPACTOR

The impactor almost touched the face of the sample when at rest. It was swung in a pendular movement to hit the sample normal to its face. The test was performed at the locations shown in Figure 5. The impact energies were 120 Nm for serviceability and 500 Nm for safety.

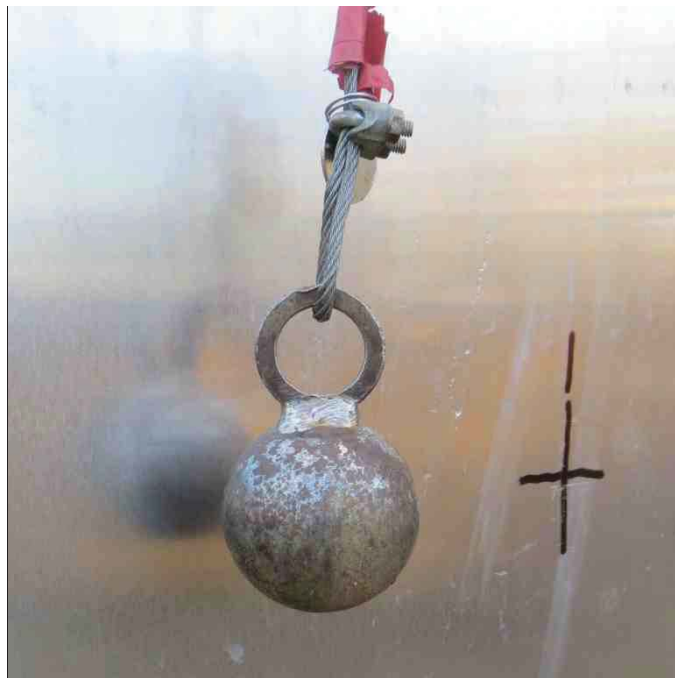
PHOTO 4696

The hard body impactor was a solid steel ball of 50 mm or 62.5 mm diameter and approximate mass of 0.5 kg or 1.0 kg.

HARD BODY IMPACTOR

The impactor almost touched the face of the sample when at rest. It was swung in a pendular movement to hit the sample normal to its face. The test was performed at the locations shown in Figure 5. The impact energies were 3 Nm, 6 Nm and 10 Nm.
