BRE Global Test Report

BS 8414-1:2015 + A1:2017 Test on aluminium hook-on cassette panel ventilated rainscreen system with Rockwool insulation.

Prepared for: d+b facades.
Date: 26th July 2019
Report Number: P114006-1000 **Issue:** 1

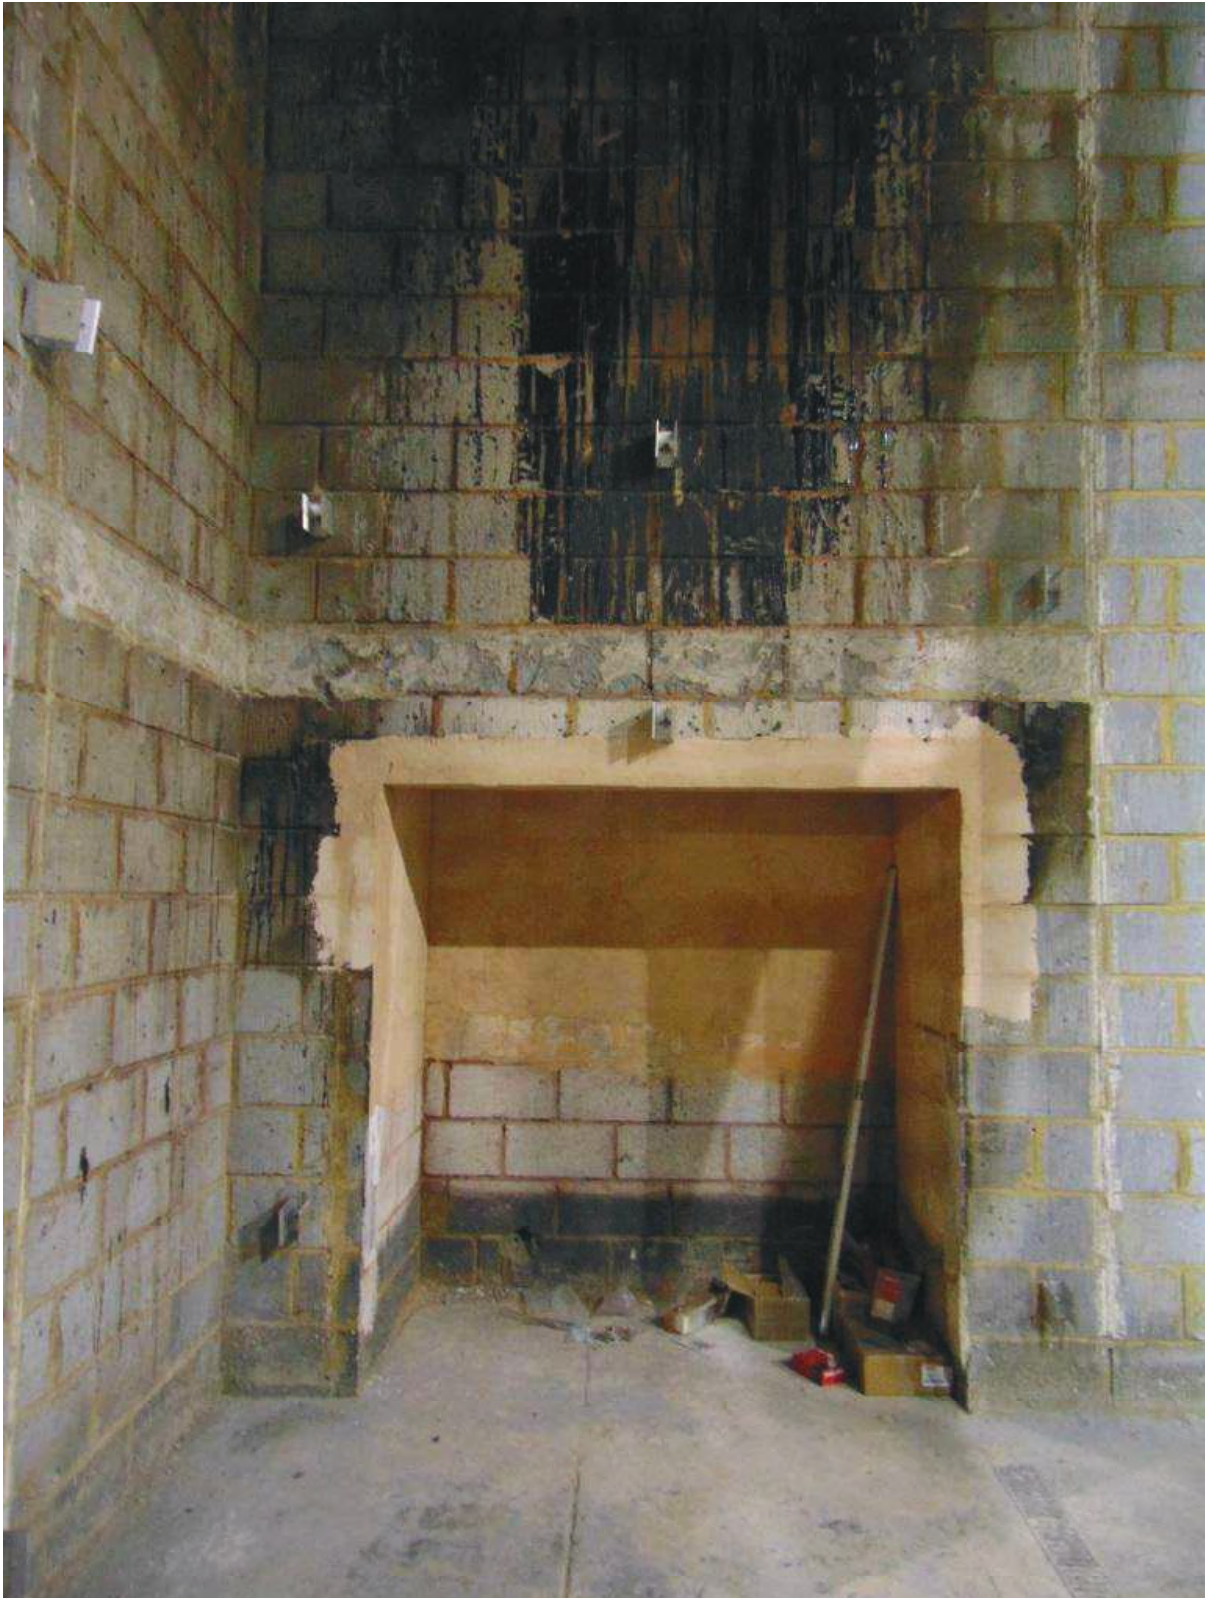
Figure 5. Installation of the aluminium brackets up to mid-height.

The system had four rows of aluminium brackets. Aluminium brackets (Item 1A) were fixed in two rows at nominal 2300mm centres up to 3321mm from the ground. Aluminium brackets (Item 1B) were fixed in two rows at nominal 2300mm centres, the first row was located 5411mm from ground. Both sets of brackets were fastened to the anchors/ threaded rods with M12 nuts with washers. See Figure 4, 5 & 6.

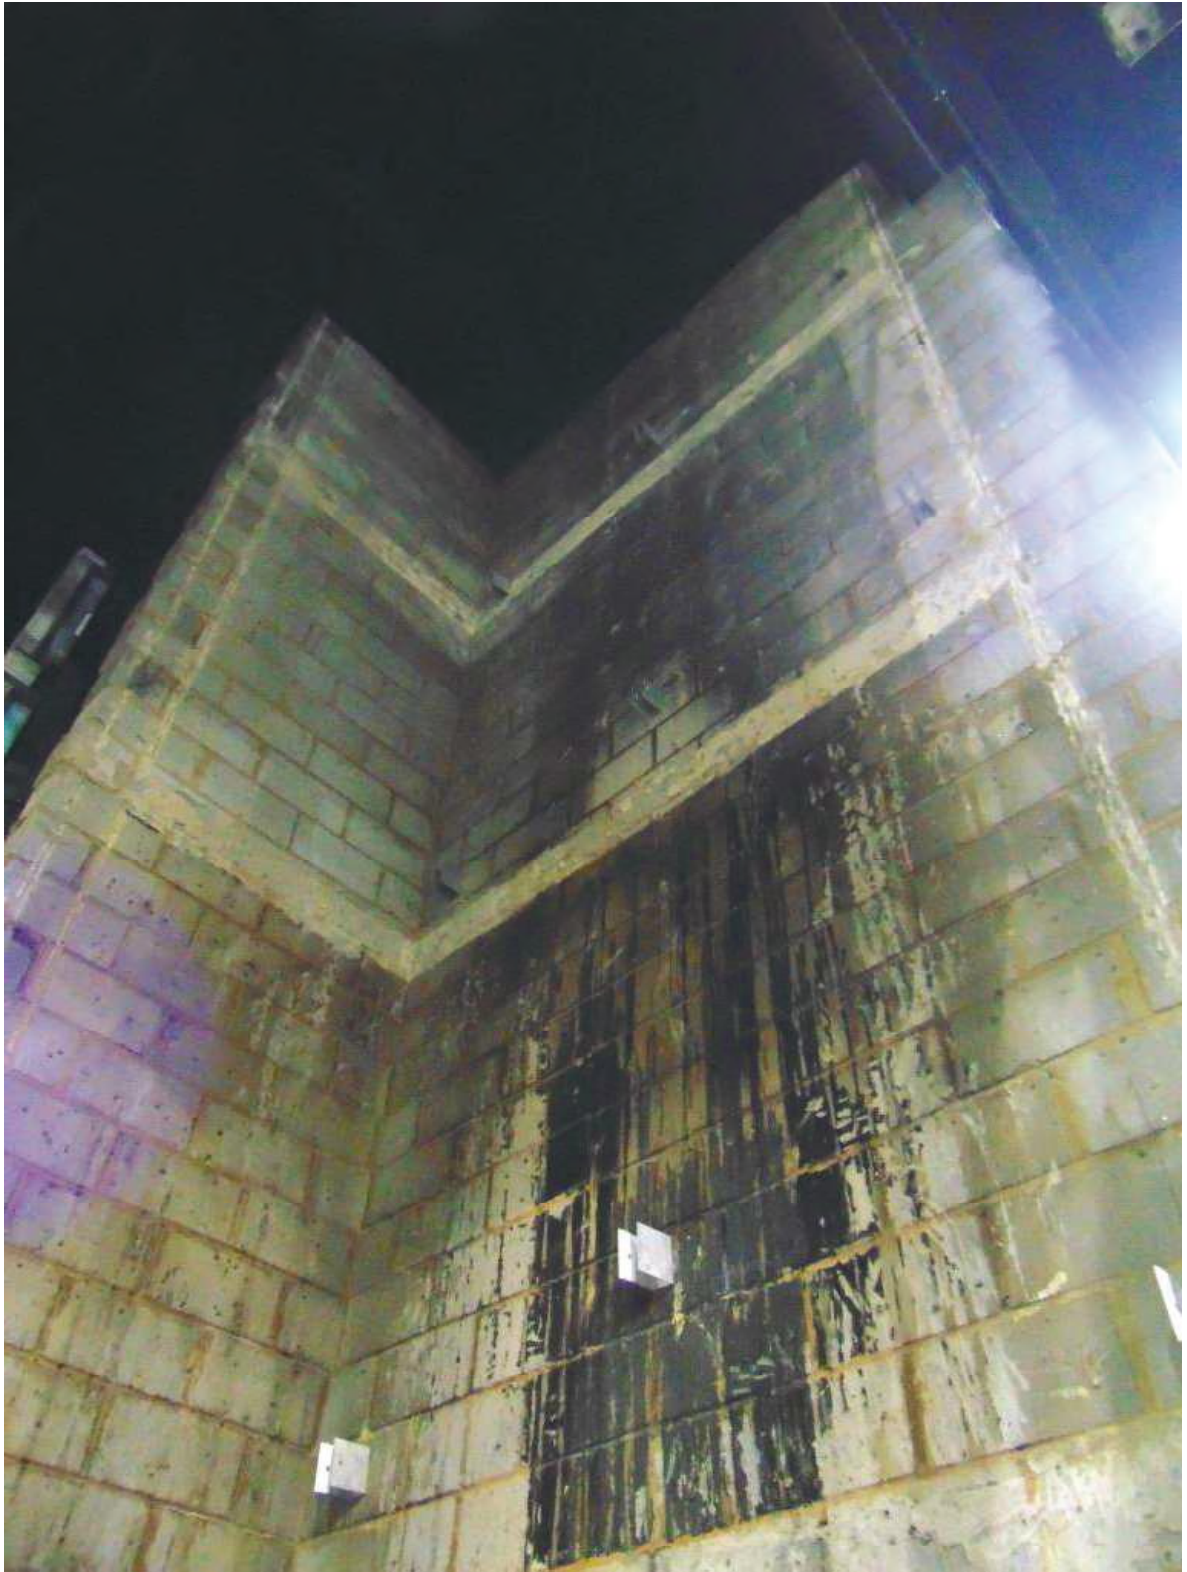
Figure 6. Installation of the aluminium brackets up to top of system.

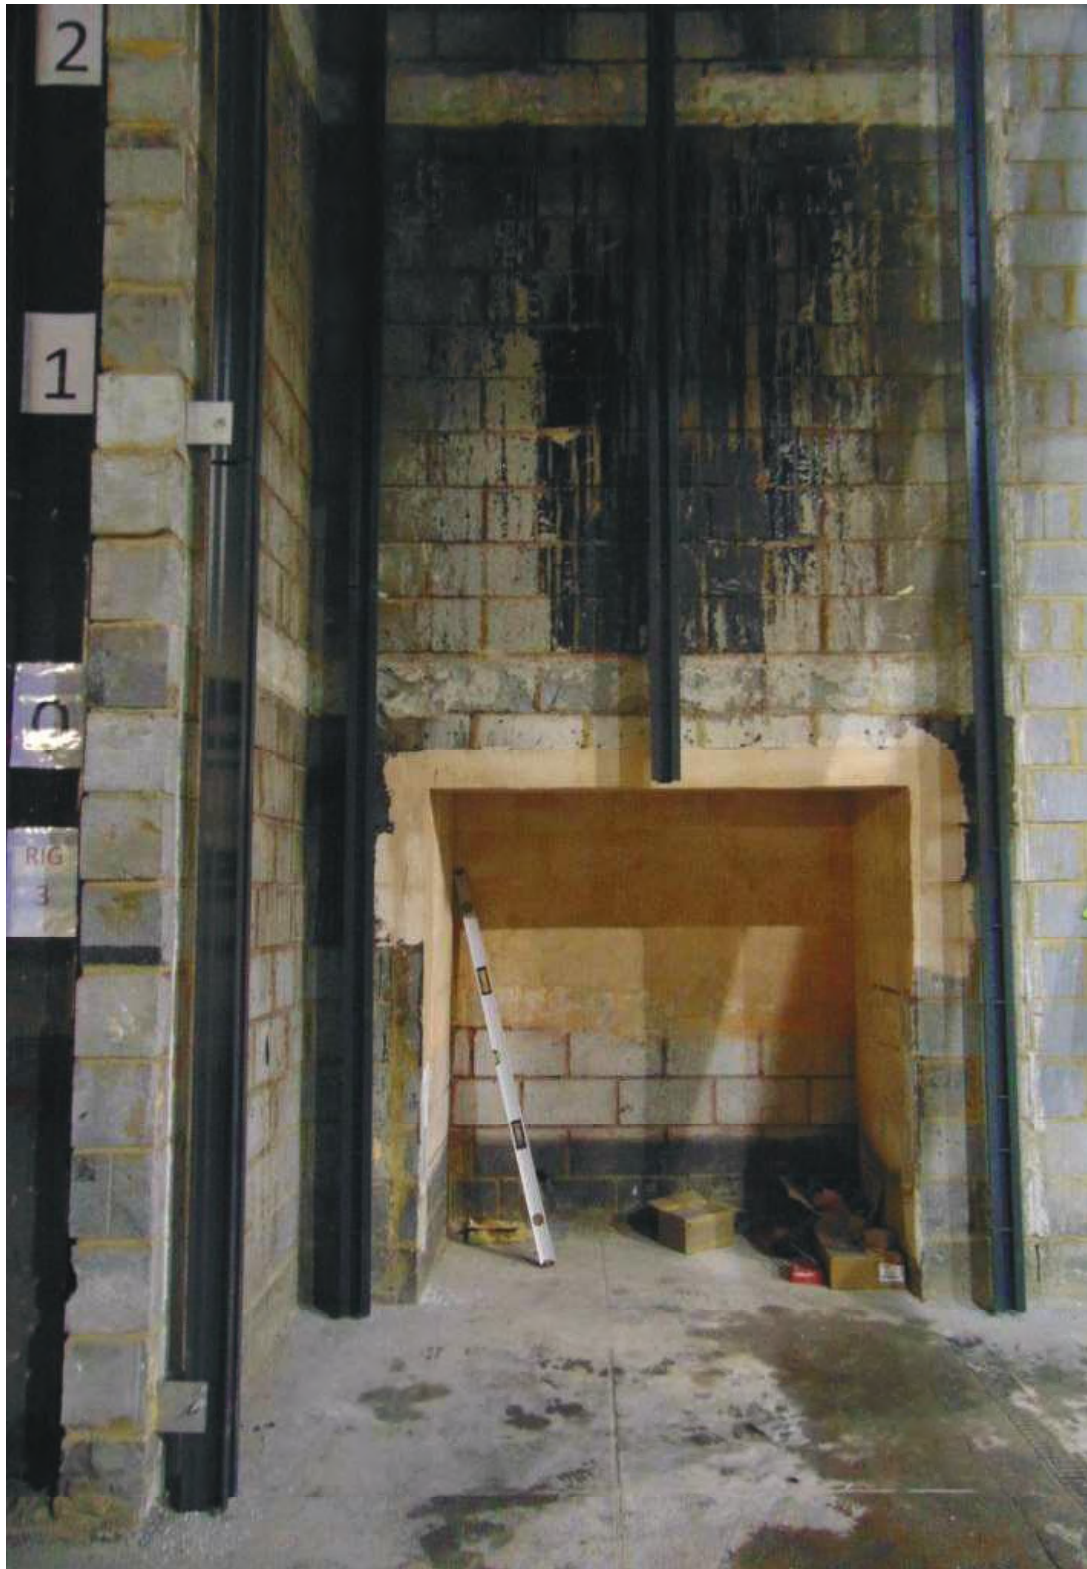
Figure 7. Installation of the aluminium rails up to mid-height.

Aluminium rails with hook-on anchors (Item 2) were fixed to aluminium brackets (Item 1A) with Ø12mm×90mm-long M12 bolts and nuts. The aluminium rails were fixed to the aluminium brackets (Item 1B) with Ø8mm×90mm-long M8 bolts and nuts. See Figure 7 & 8.

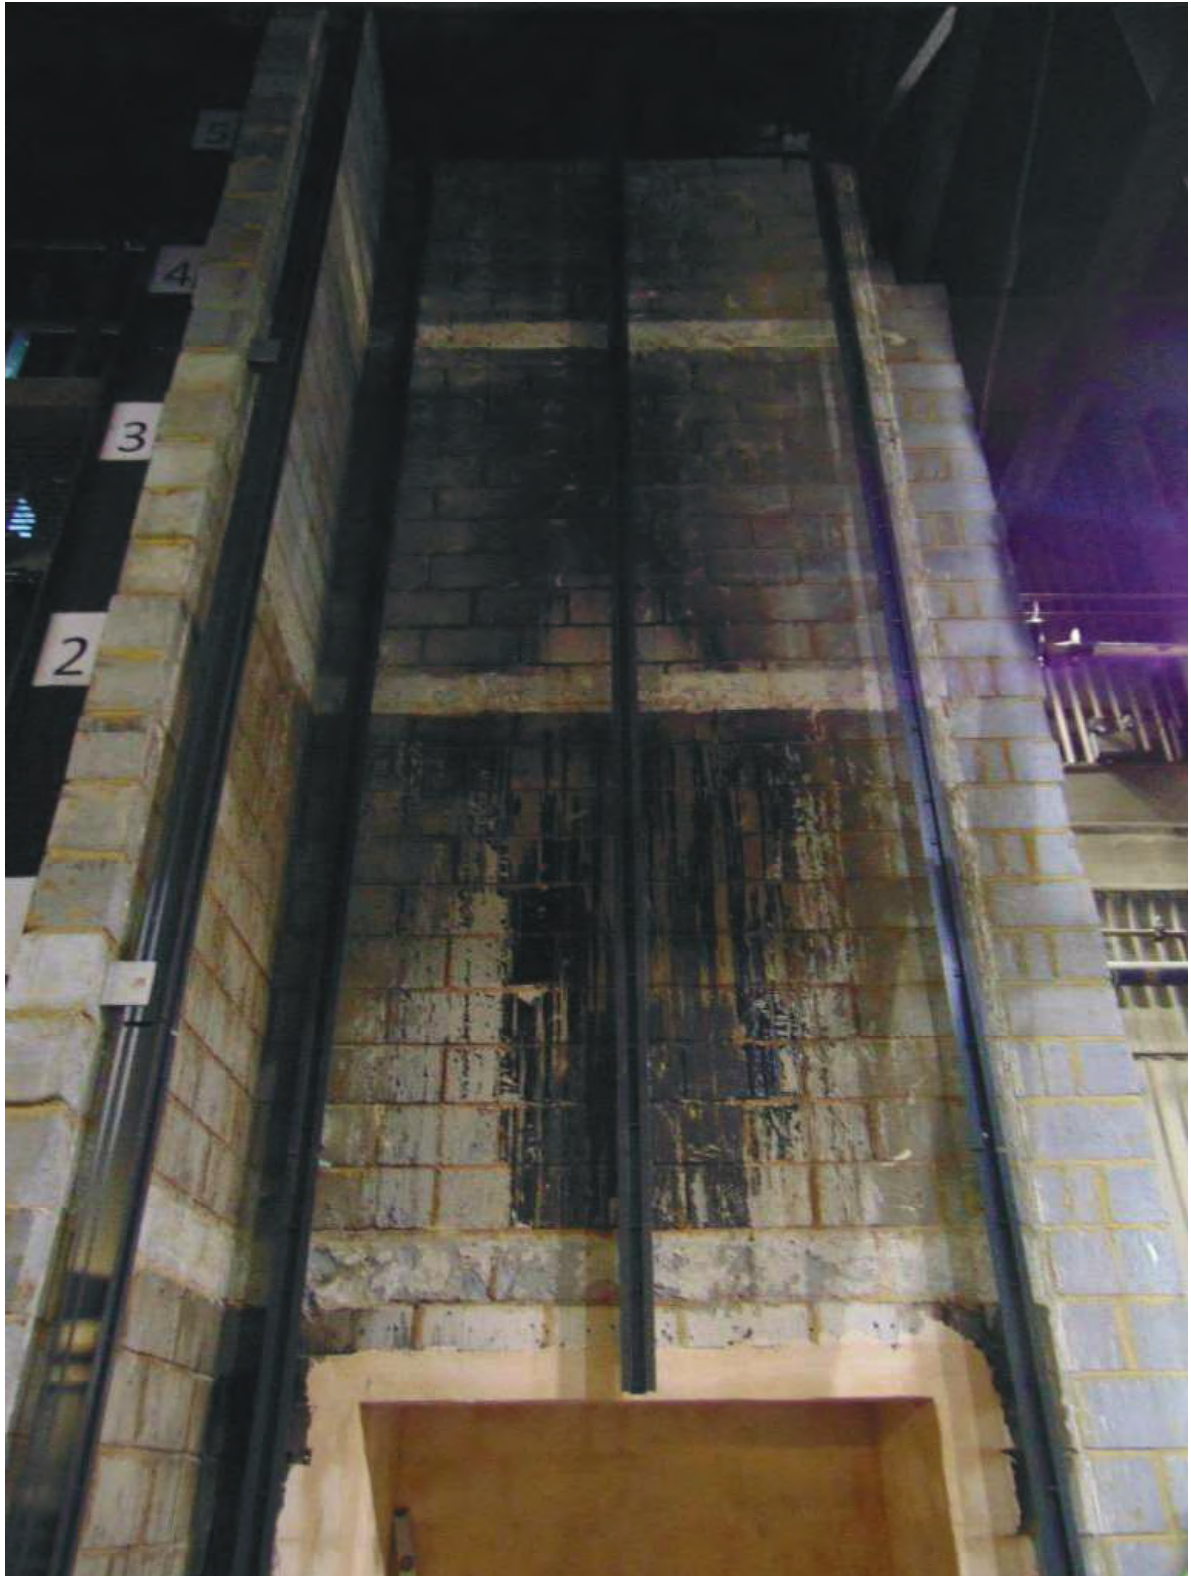
Figure 8. Installation of the aluminium rails up to top of system.

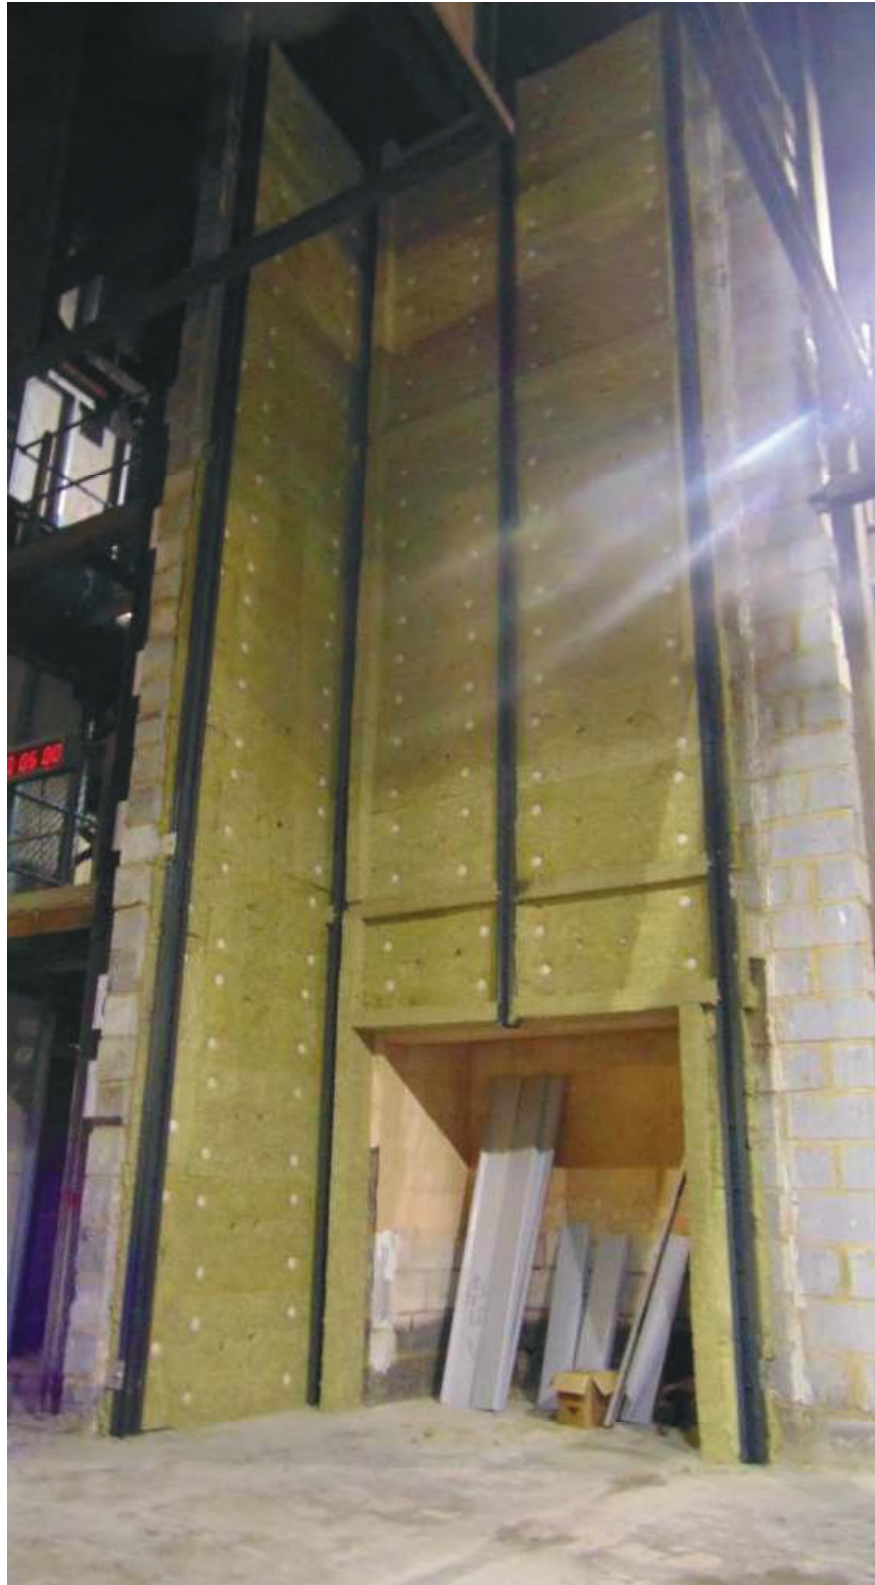
Figure 9. Installation of the insulation, horizontal and vertical cavity barriers.

Rockwool RW5 (Item 4) was cut to 195mm-deep and pressed onto the galvanised steel skewers (Item 3) as horizontal barriers to the two rows, intersected by the aluminium rails with hook-on anchors (Item 2). See Figure 9.

Rockwool RW5 (Item 4) was pressed onto the galvanised steel skewers (Item 3) as a vertical cavity barrier and was intersected by the horizontal cavity barriers. See Figure 9.

Rockwool RWA45 Insulation (Item 5) was fixed as vertical slabs onto masonry substrate with four Hilti 250 IDP 10/12 plastic plugs (one at each corner) and two Hilti 150 IDMR 9/12 77846 metal plugs (towards the centre), per full slab. See Figure 9.

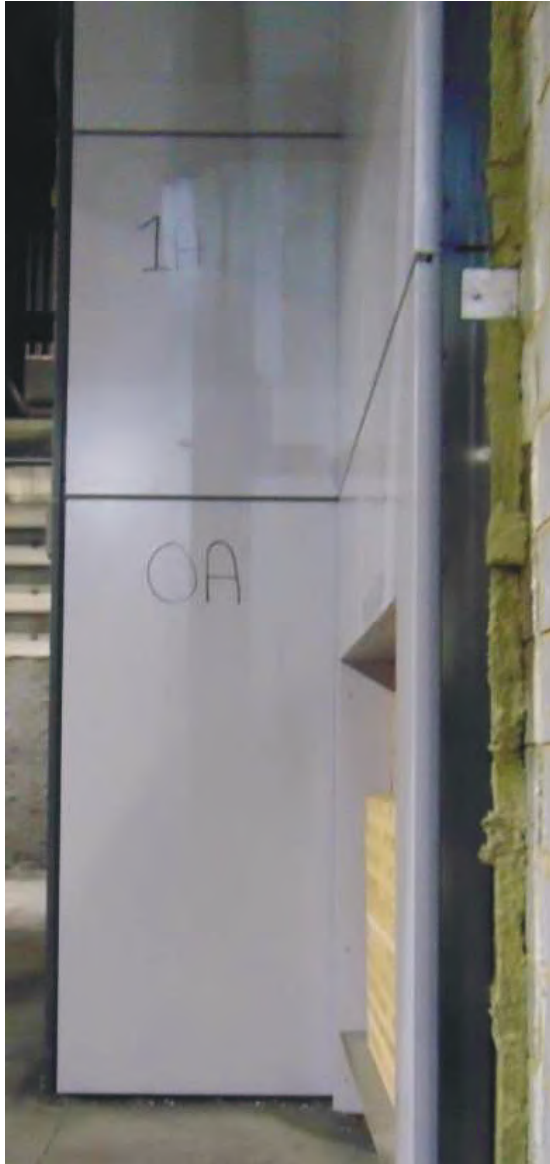
Figure 12. Photographs of completed build prior to test up to mid-height.

Aluminium hook-on cassette panels (Item 7) were hooked onto the aluminium rails with hook-on anchors (Item 2). The panels were secured to the rails with Hilti S-MD 53 S Ø5.5×38mm-long self-drilling screws with Ø12mm washer at each corner of the panel. Panel gaps were approximately 20mm. See Figure 11, 12 & 13.

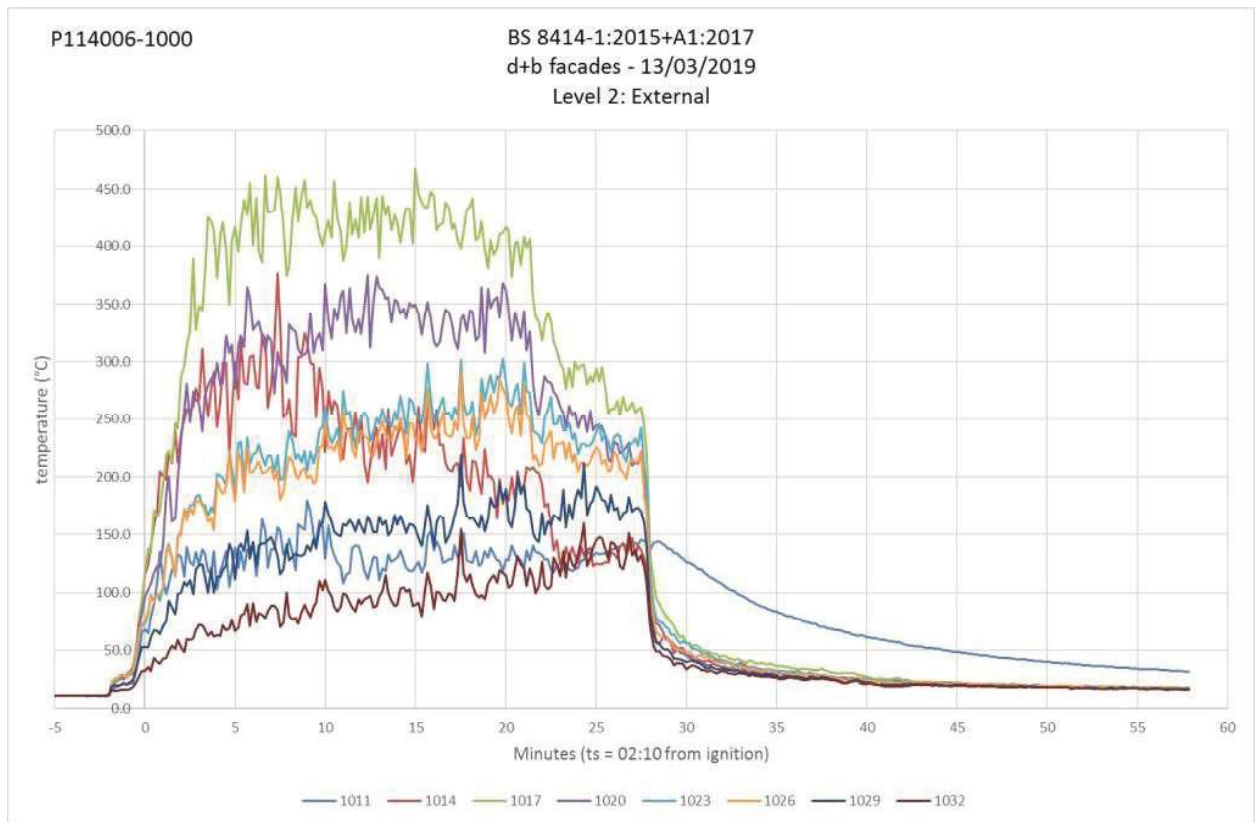
Figure 16. Level 2 external thermocouples.

$t_s = 2\text{mins } 10\text{secs}$ after ignition of the crib.

Parameter	Result (whole test)	Result (t_s+15 mins)
T_s , Start Temperature	11°C	n/a
t_s , Start time	02:10 after ignition of crib.	n/a
Peak temperature / time at Level 2, External	467°C ($t_s+15:00$).	467°C ($t_s+15:00$).
Peak temperature / time at Level 2, Cavity	704°C ($t_s+23:20$).	405°C ($t_s+15:00$).
Peak temperature / time at Level 2, Insulation	54°C ($t_s+39:50$).	23°C ($t_s+15:00$).

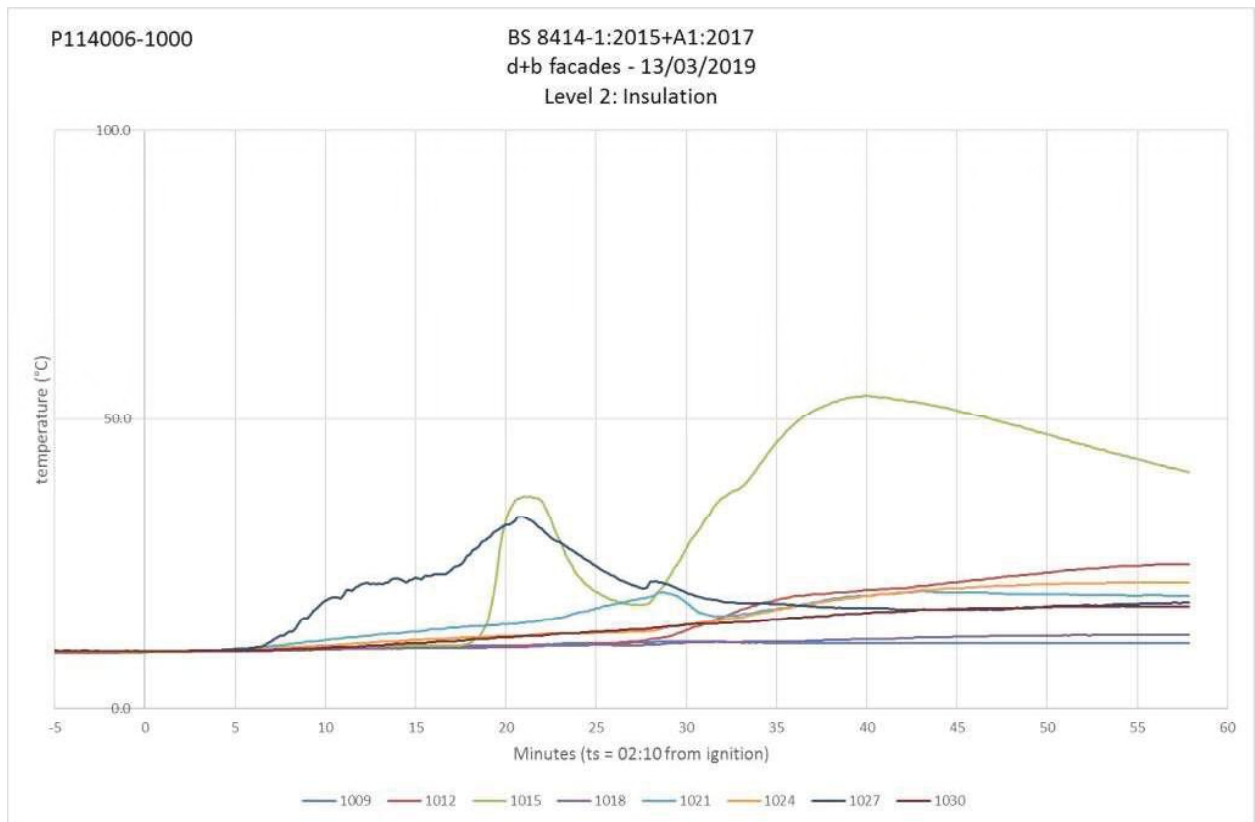
Figure 18. Level 2 plasterboard layer thermocouples.

$t_s = 2\text{mins } 10\text{secs}$ after ignition of the crib.

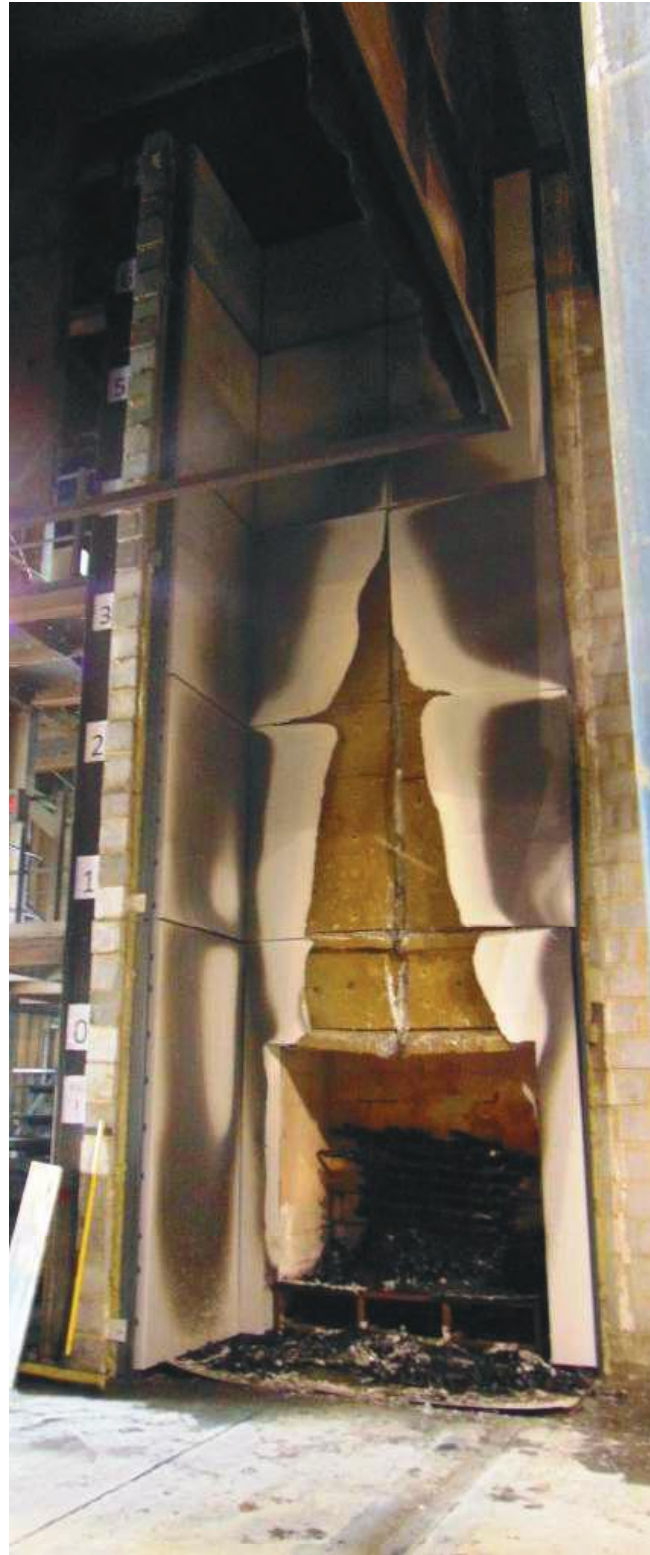
On the main wall the aluminium panels were consumed in an area approx. 1.5m-wide×4.1m-high in a triangular fashion (approx. 3.1m²) that tapered from max width of the combustion chamber opening. The panels were distorted and discoloured up to the base of panels 4B & 4C. On the wing wall the panels were distorted and discoloured up to panel 3A. *See Figure 19.*

Figure 19. Full-height photograph of cladding system immediately after test.

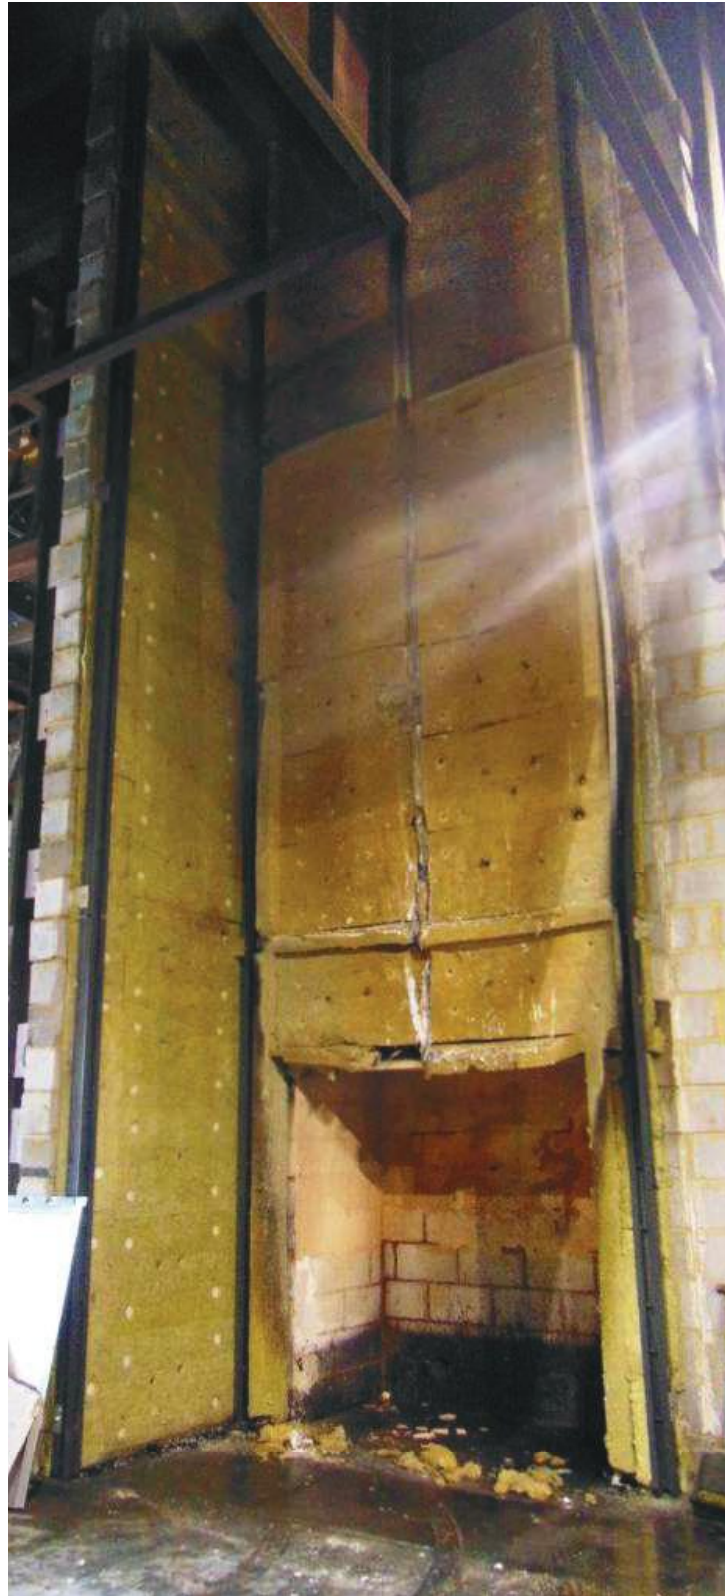
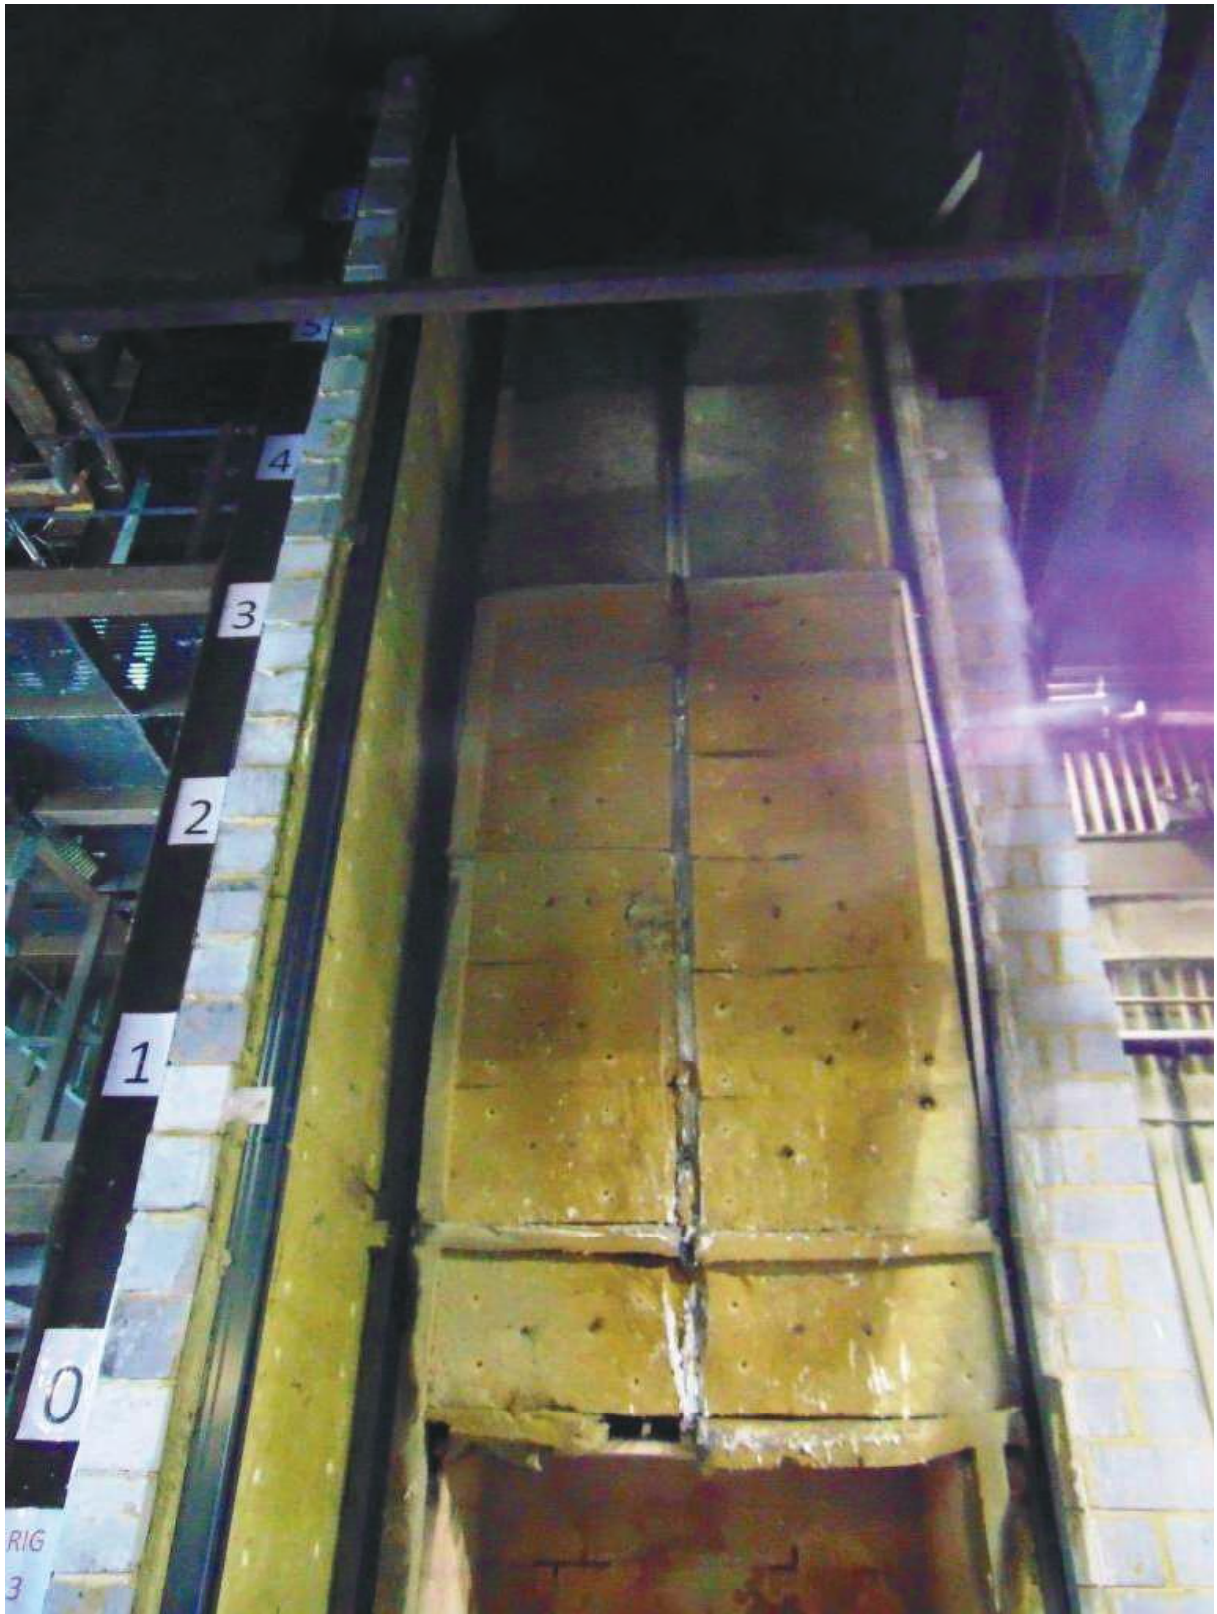
On the main wall, the insulation was discoloured up to the top of the system. On the wing wall the insulation had sections discoloured along the main-wing wall junction up to the top of the system from above the combustion chamber opening. *See Figure 20 & 21.*

Figure 20. Full-height photograph of the insulation.

Figure 21. Close up of insulation.

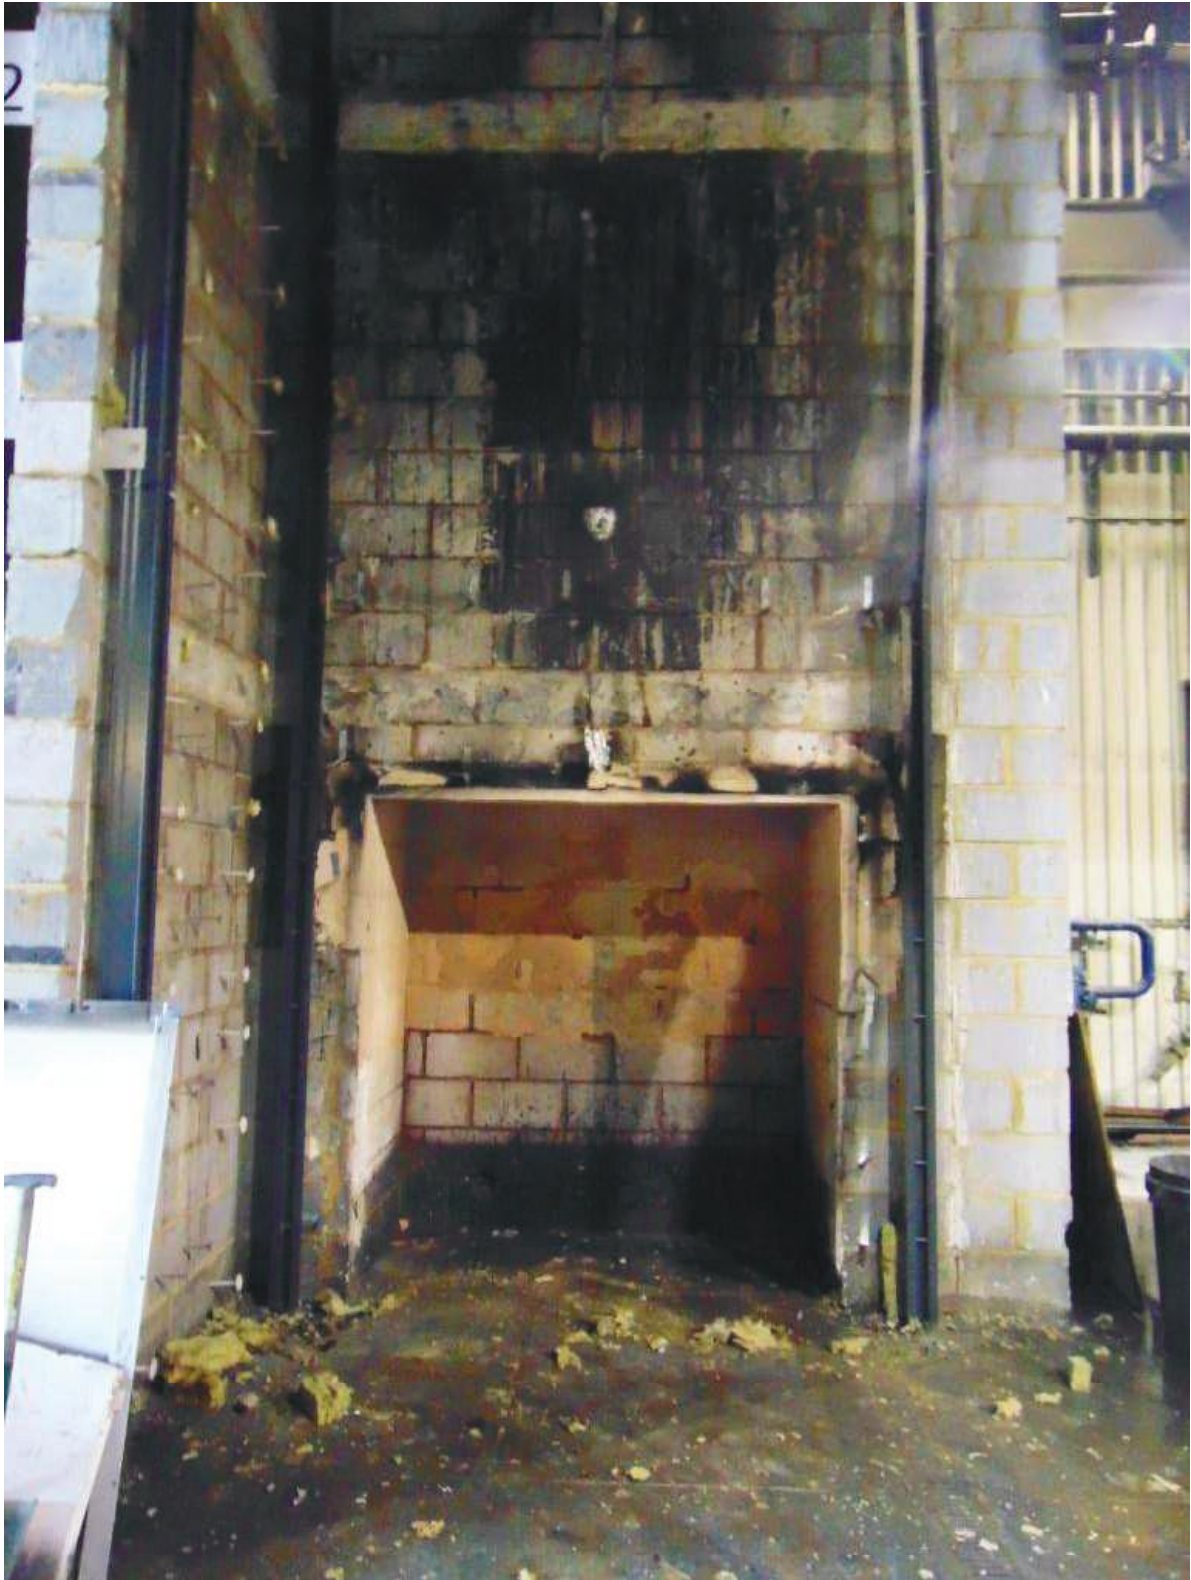
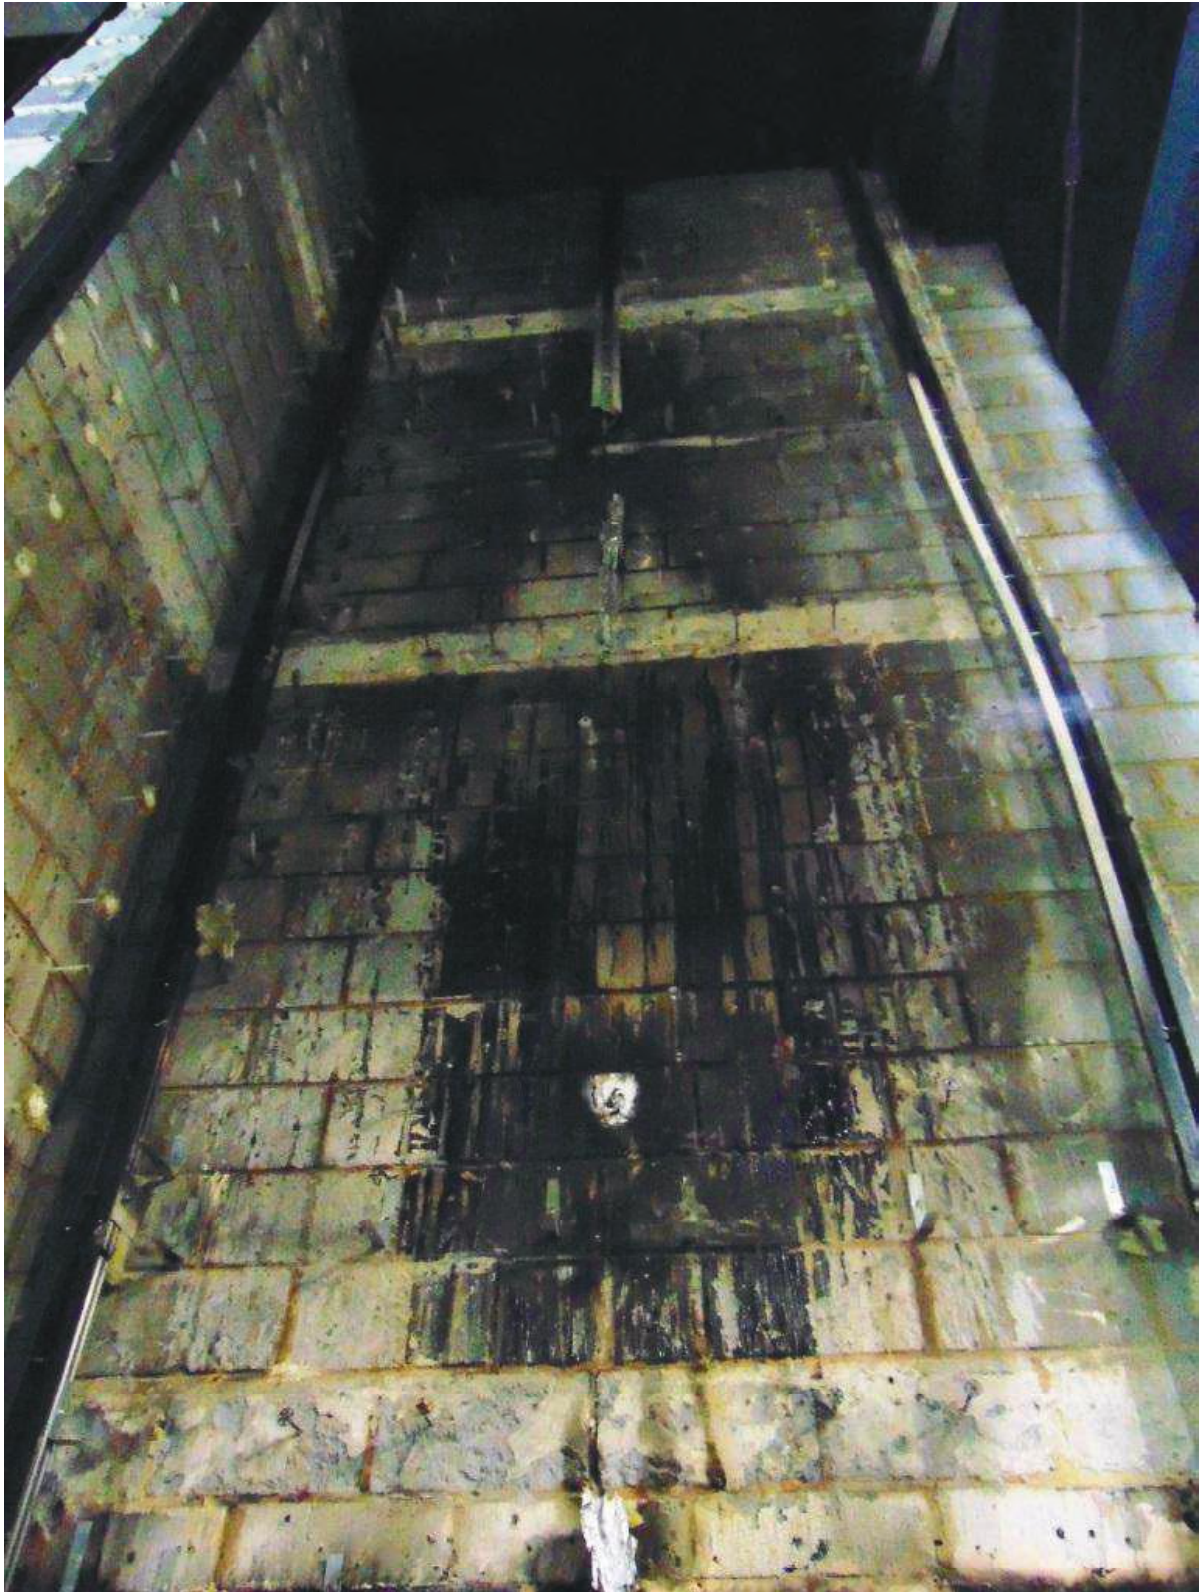
On the main wall, the central rail and brackets in line with the combustion chamber centre line, were consumed up 4300mm and discoloured up to 5200mm above the combustion chamber opening. The rail located at the outer edge of the main wall was distorted from 800mm to 4000mm and discoloured up to 4300mm above the combustion chamber opening. The rail located at the main-wing wall junction had patches of discolouration up to 4300mm above the combustion chamber opening.

On the wing wall, the rail and brackets located at the outer edge of the wall was intact with no visible damage.

Figure 24. Photograph of the aluminium rails up to mid-height.

Figure 25. Photograph of the aluminium rails up to top of system.

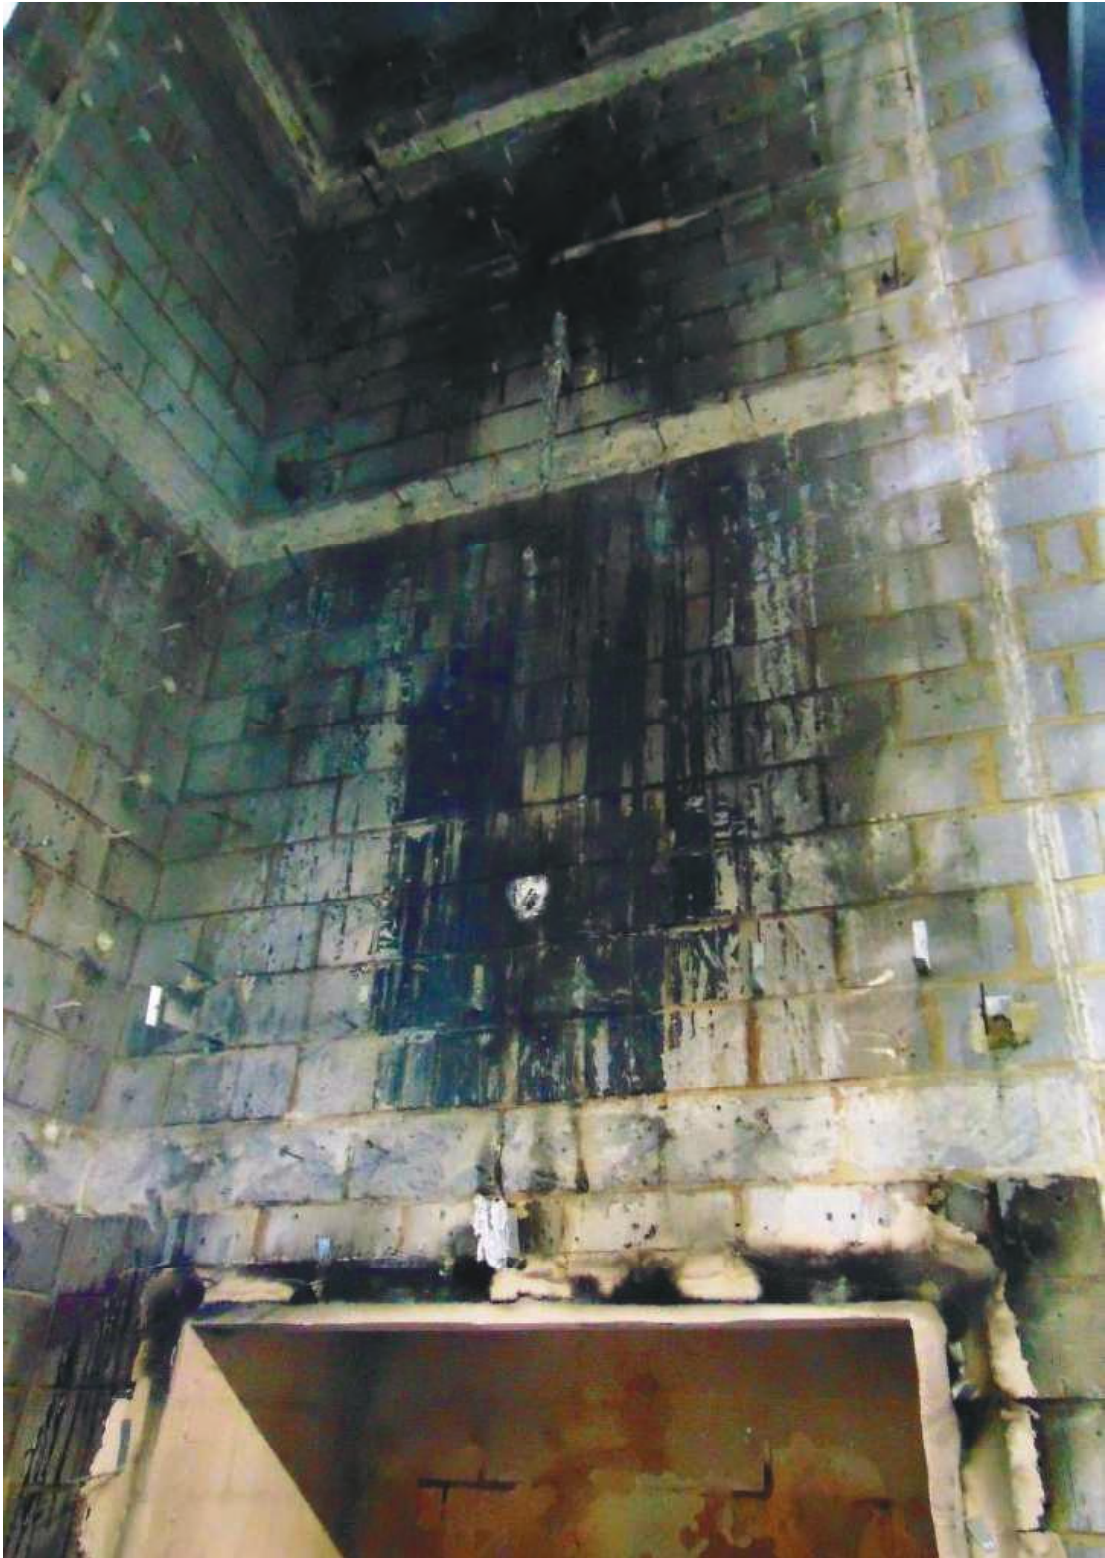
Figure 26. Photograph of the aluminium brackets.
